# Safety Glass – Position Statement

## Background

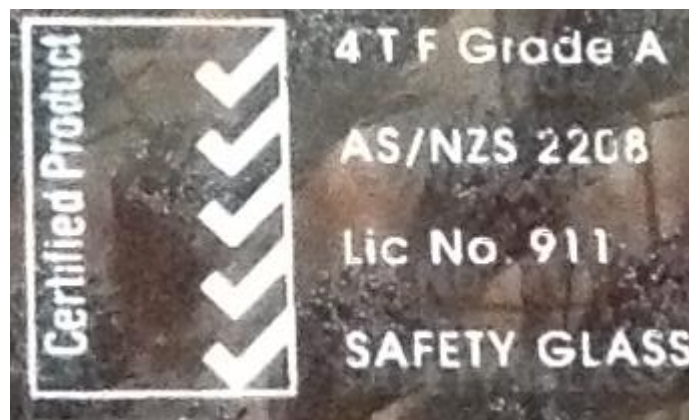
Each piece of the glass tested was permanently marked with the following logo, certifying its conformance with all the requirements of toughened safety glass as specified in AS/NZS 2208.

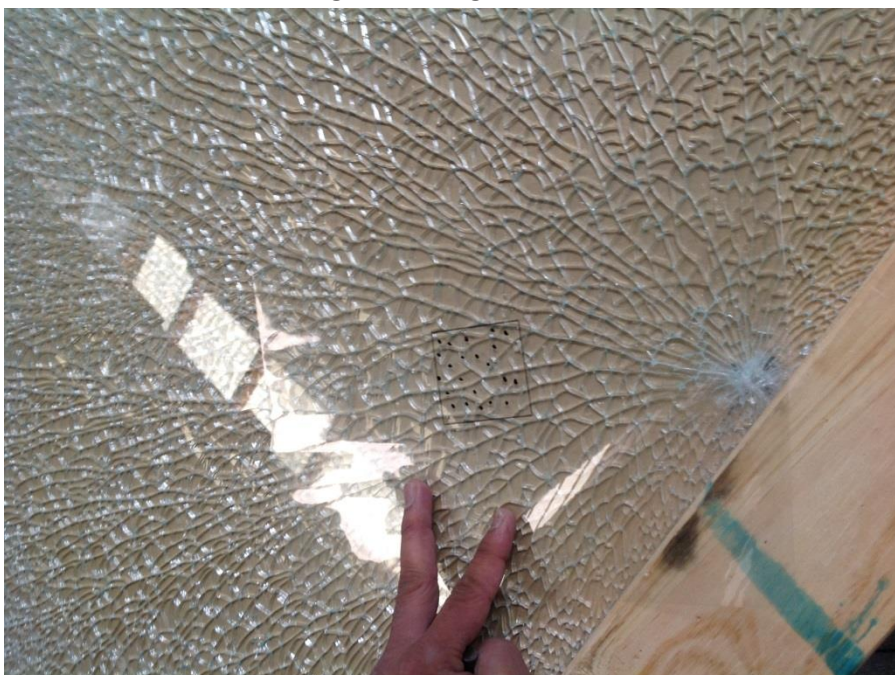
**Test 1 – Glass is broken 13mm from the edge according to the test method in AS/NZS 2208.**

As can be seen in the image above, when the pane of glass was broken using the test method in the current Australian Standard (broken 13mm from the longest edge), it breaks into small particles.

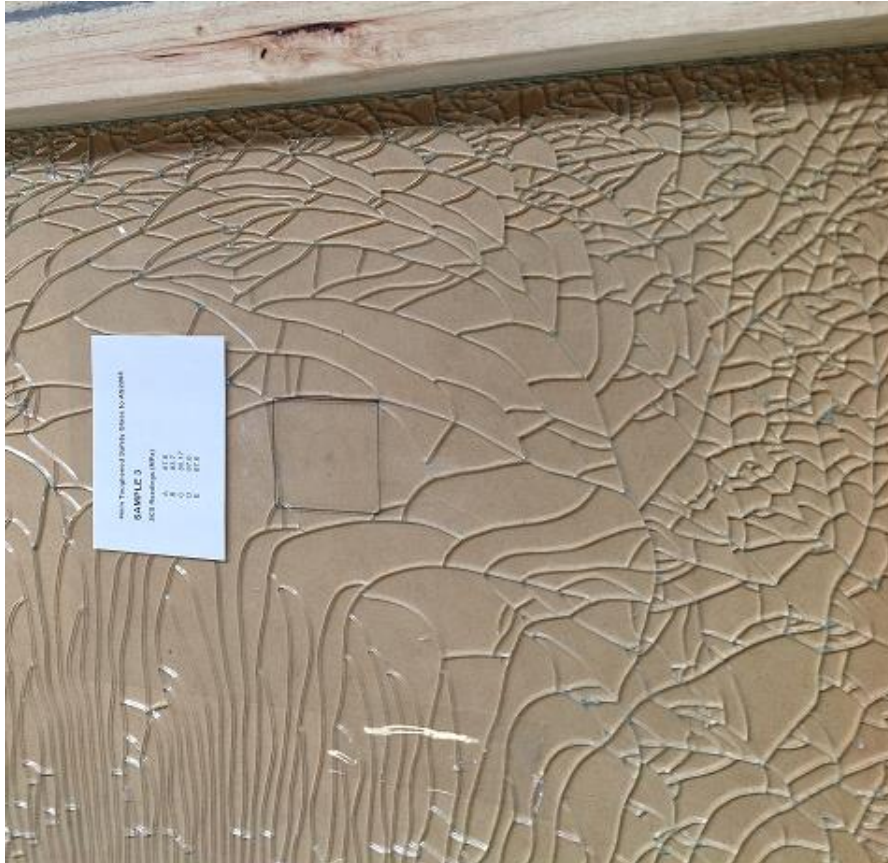
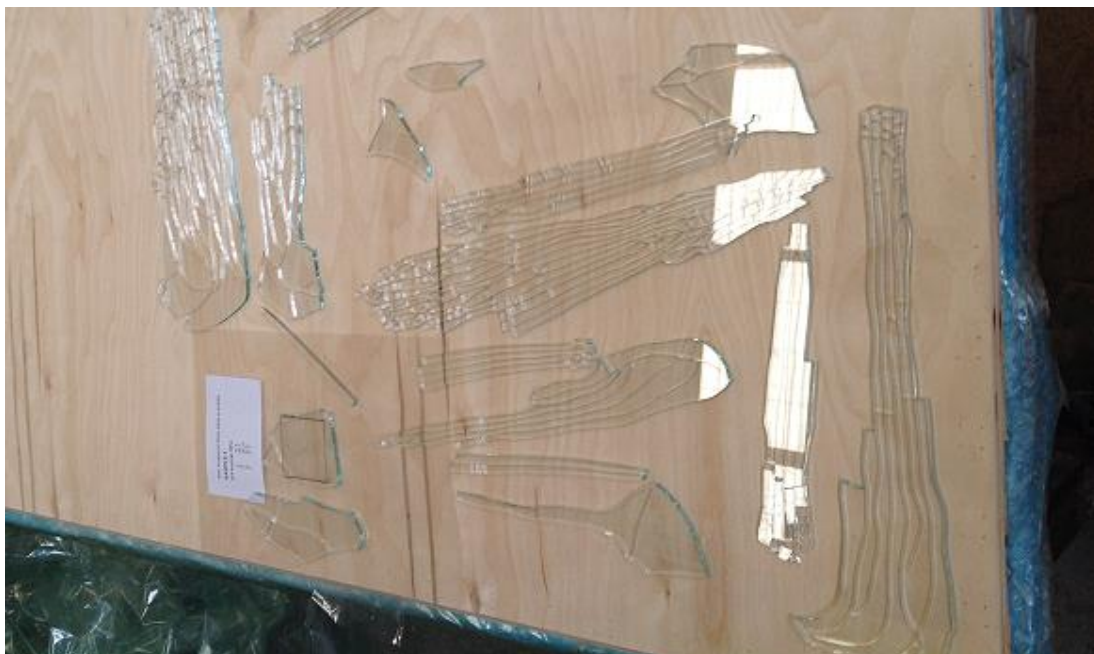
**Test 2 – Glass is broken using the fragmentation test, but at the CENTRE of the glass – this test is not currently specified in the Australian Standard AS/NZS 2208.**

As the images above show, when the pane of glass was broken in the centre (and not near the edge as specified in the current Australian Standard), the glass breaks into large, sharp pieces which could potentially cause serious injury.

The main concern lies with the test method used to break the glass to determine if it can be classified as toughened safety glass. The most commonly used test method involves breaking the glass near the edge of the pane - 13mm from the longest edge, which will usually result in the glass breaking into small particles as required for certification according to the Standard. However, when the glass is broken by impact away from the edge - as is more likely to occur if a person was to impact the glass - testing has demonstrated that the glass fragments may include long shards. If the test method in the Standard was changed to require fragmentation at the panel centre, the same piece of glass which passes the most commonly used testing

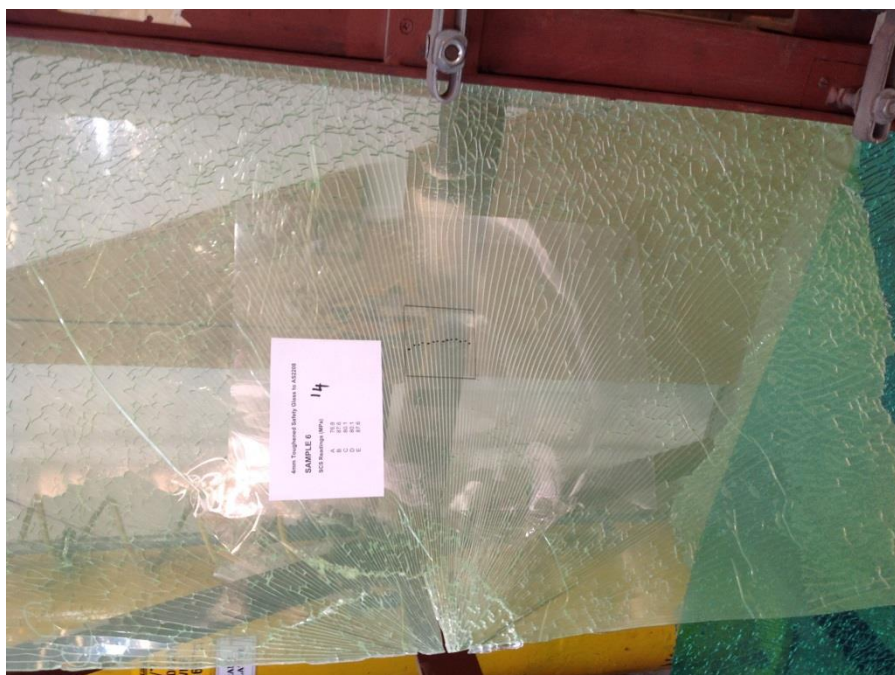
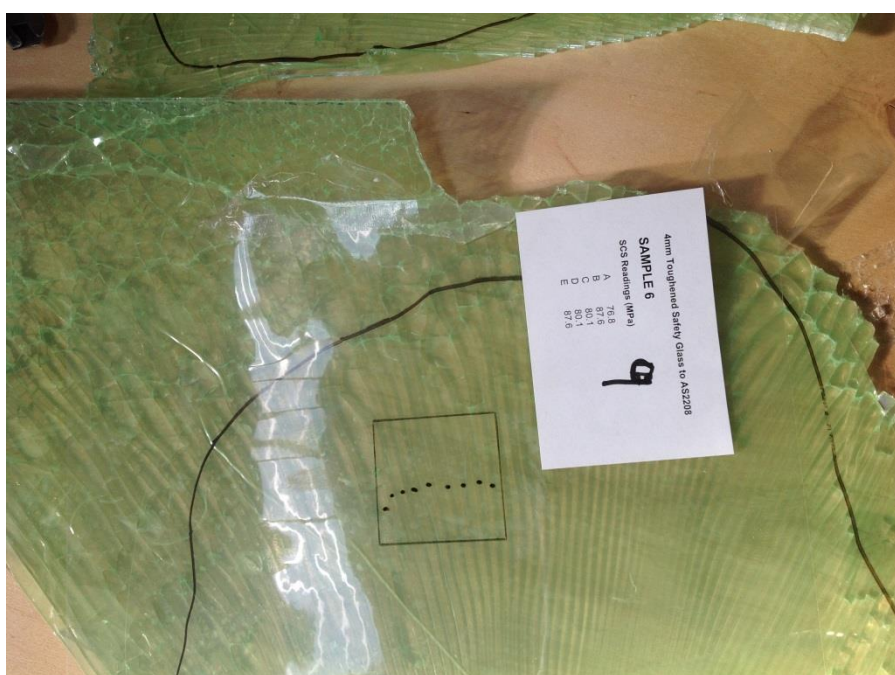
**Test 3 – Pendulum impact test - specified in the Australian Standards as an option, but generally not used to test and certify toughened safety glass. The acceptance criteria for this test in AS/NZS – 2006 allow certification of product even if long dangerous shards are generated, a deficiency that requires amendment. This test simulates human impact in the centre of a panel.**

As the above images demonstrate, when the certified piece of toughened glass was broken using the pendulum impact test - which is specified in the Australian Standard, however rarely used by manufacturers to test their safety glass - the glass generated hundreds of long, sharp pieces which could potentially cause serious injury.
