Man dies after broken shower glass pierced his neck: Coroner

The New Paper | Shaffiq Alkhatib | Thursday, Oct 1, 2015

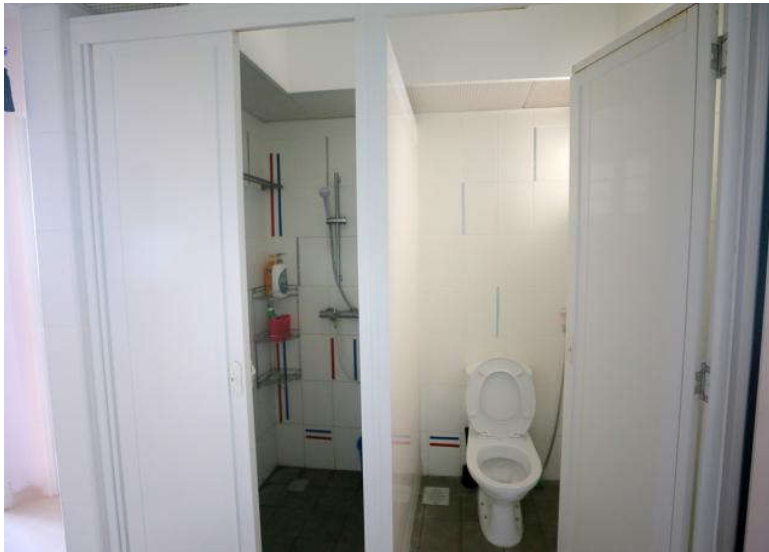
Photo: Shin Min

He slipped, smashed his head through the glass panel of a bathroom door and later died.

When Mr Wong hit the glass panel, the sharp broken edges impaled his neck. He also had multiple cuts on his head.

It revealed that the panel was not made of tempered glass.

Instead, Coroner Bay said that it was likely to be made of heat-strengthened glass.

In his findings, he added that it may be prudent to use tempered glass panels on doors or windows in places where falls may commonly occur.

He said: "Tempered glass fragments are less likely to have sharp edges (when broken), which may help to avoid the occurrence of catastrophic or even fatal injuries, upon any person breaking or shattering glass
