Response to the evidence presented by the Australian Glass and Glazing Association at the February 15, 2016 hearing of the Senate Economics Committee into Non conforming building products.

## **Results, Conclusions and Recommendations Relating to AS/NZS 2208**

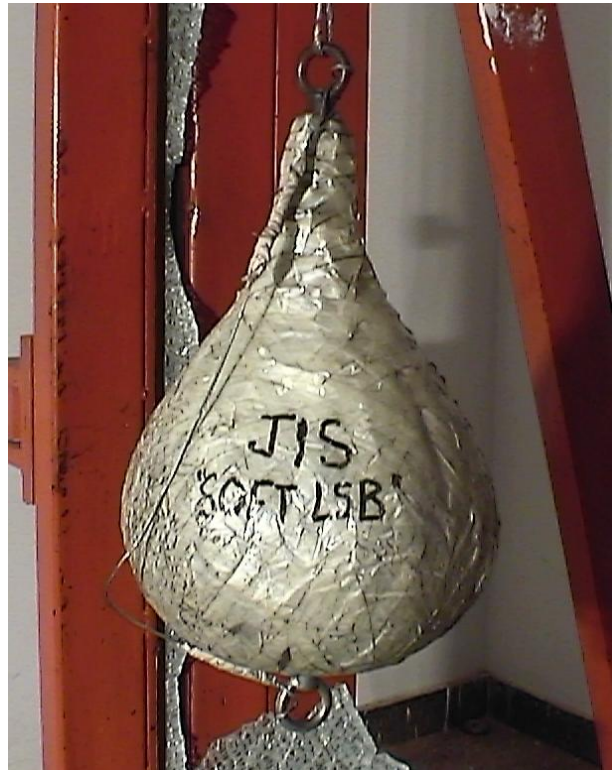
**JIS 'Soft'  
Lead Shot Bag**

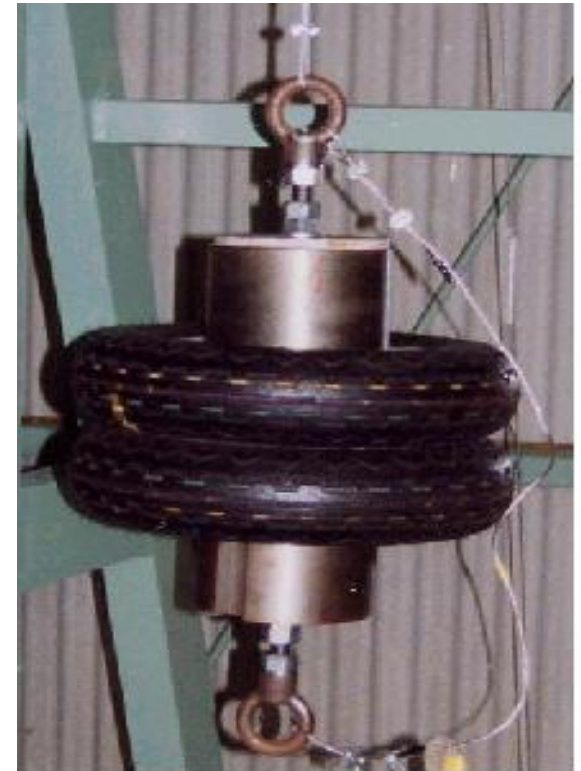
**EN 12600  
Twin Tyre**

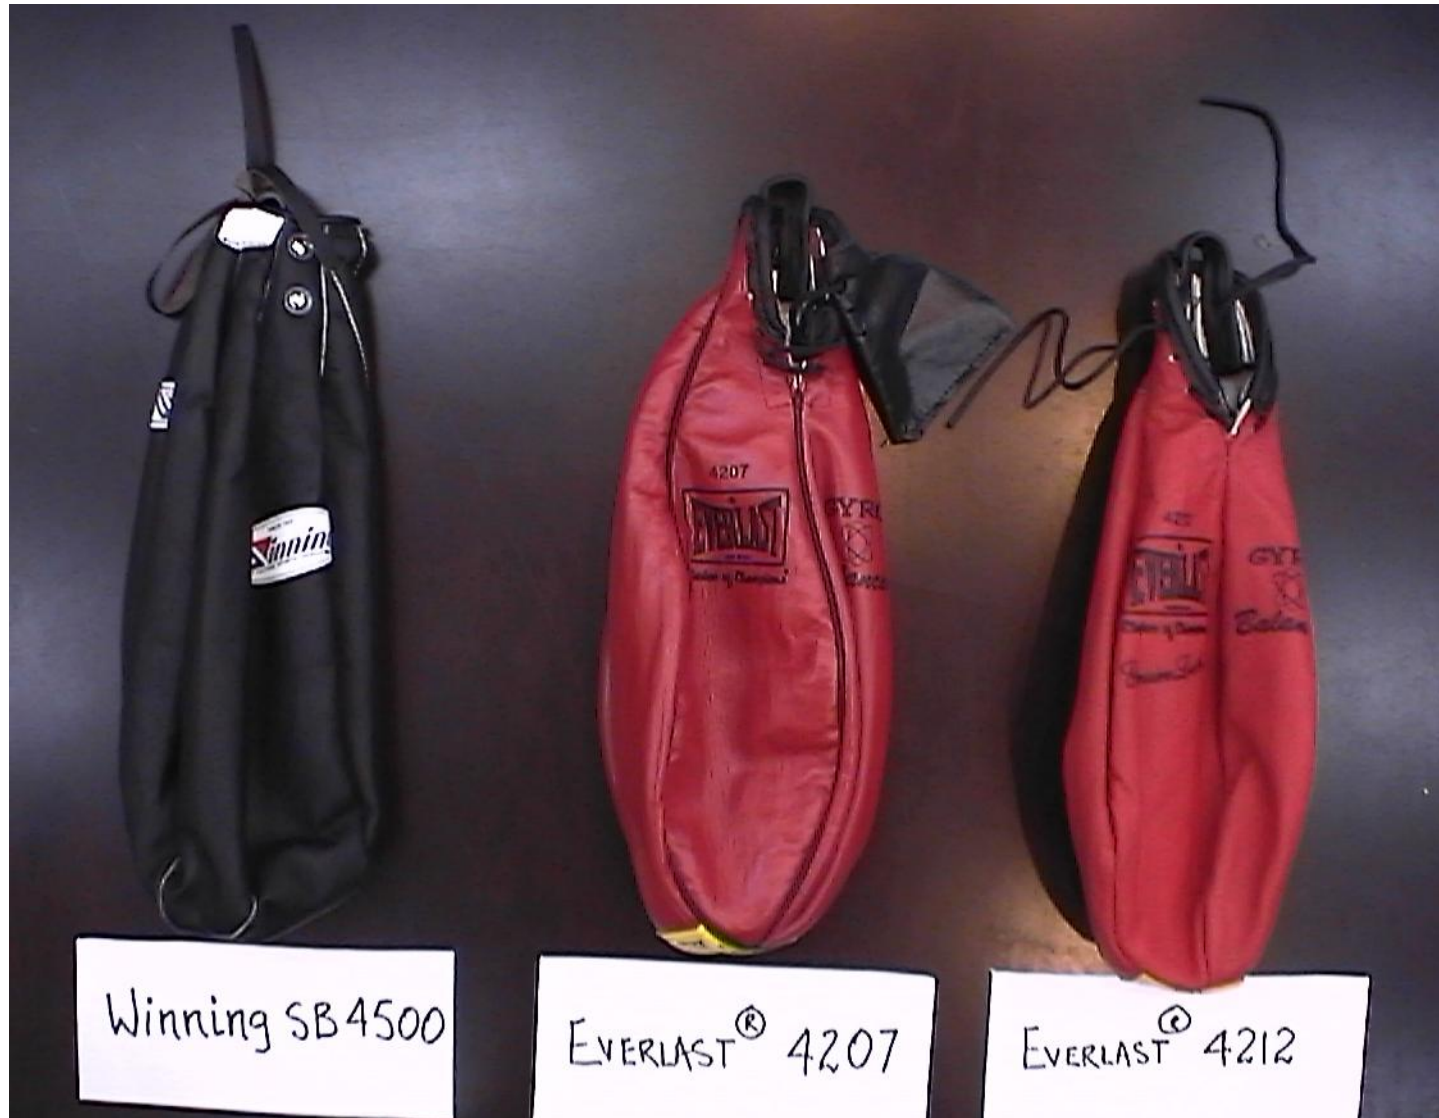
# Leather Bags for Lead Shot Bag Impactors

JIS 'Soft' Bag

ANSI Z97-1 Bags

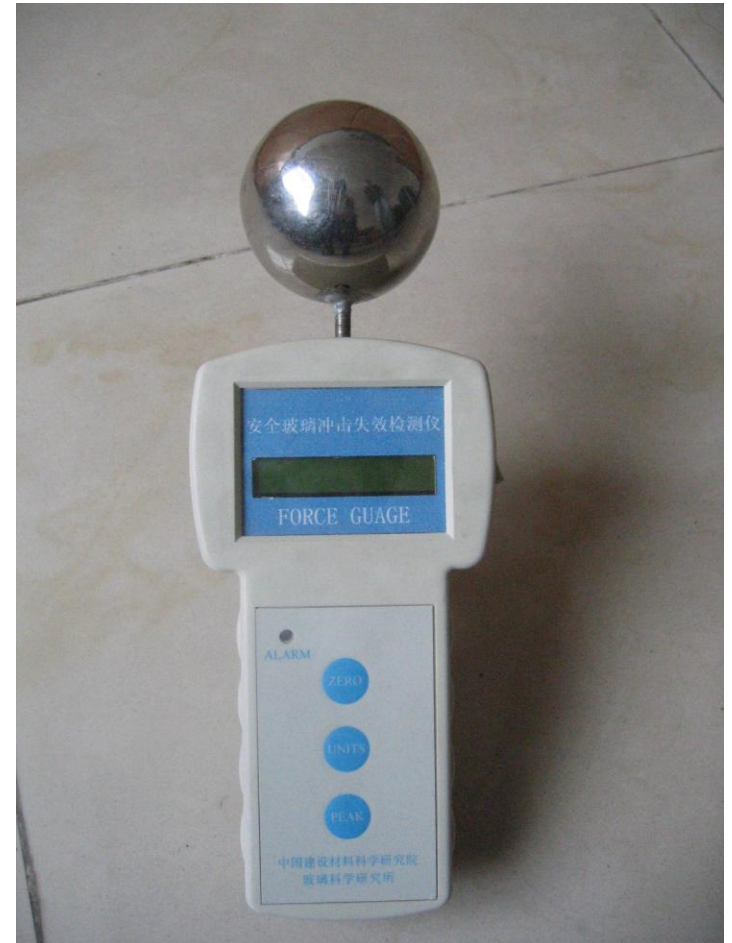
Staircase testing of 6.38mm laminated glass to determine mean penetration height was facilitated by development by the CSGC of an improved force gauge And probe (76mm sphere) assembly

The test result is a “Pass” if the sphere does not pass through the impacted laminated glass with an applied force of 25 Newtons. At this force a “beep” occurs.

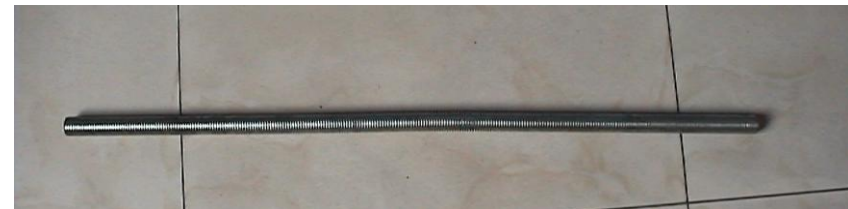
It was eventually found that the 20mm Diameter spindle shaft in the impactor was bent.

This was replaced by a 30 mm diameter shaft and good staircases were obtained.

Staircase impacts with 6.38 mm laminated glass with twin tyre impactor having a 20 mm diameter spindle shaft

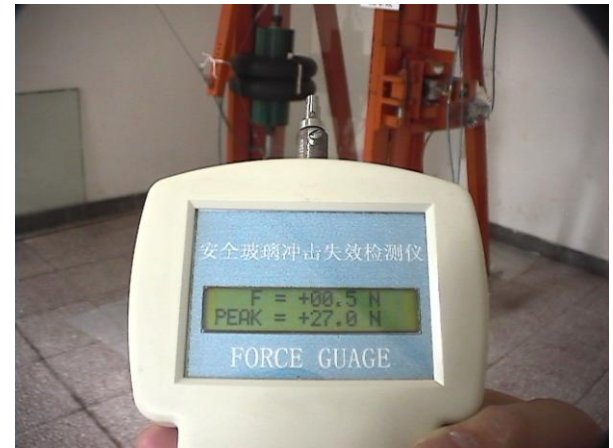
Flaws were applied with a Vickers indenter (VI) at 25N to panels that did not break (DNB) at 1200 mm drop height

- It was found that if a very light scratch was applied to a panel of toughened glass at or near the impact point the impact resistance of the glass was greatly reduced.
- A method was developed using a Vickers indenter with a controlled force to apply a reproducible spot of damage to the impact point of tempered glass panels. This damage is typical of that incurred during glass use and results in breakage at 300mm drop height with the twin tyre impactor of panels that had remained unbroken at 1200mm drop height.

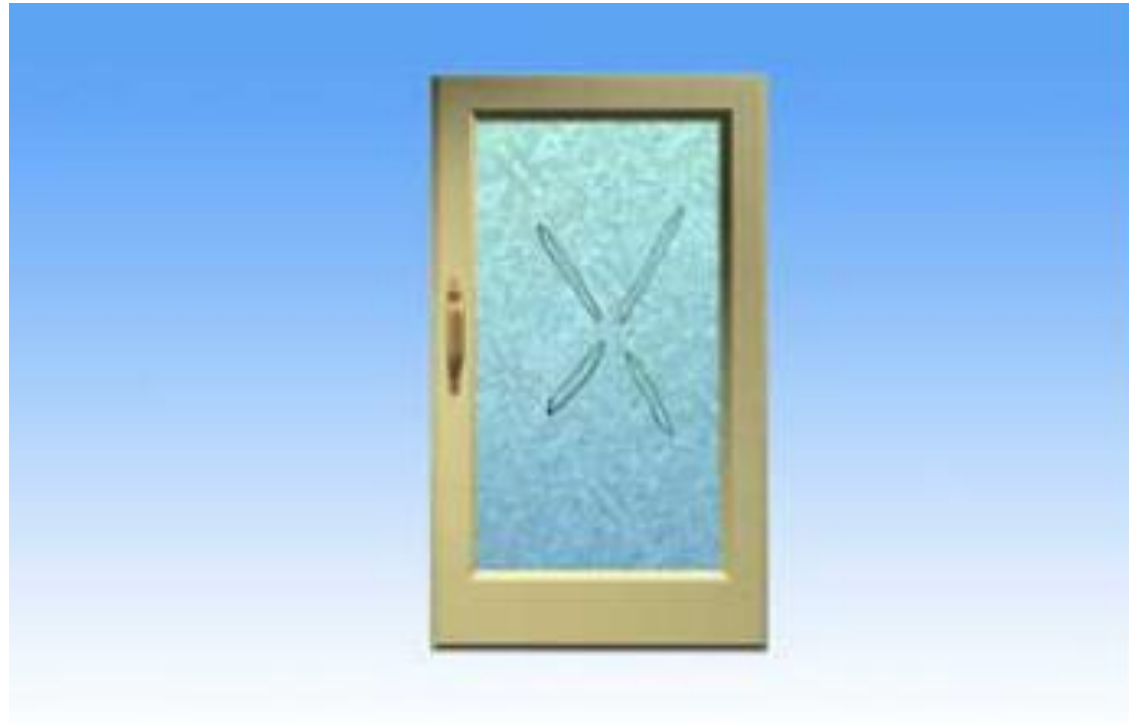
## Long Particles – GPD 2001, Vitkala

*Figure 8 If the glass temperature is not correct or even enough before tempering, it will not fulfil the requirements of tempered safety glass. If the glass breaks, it breaks in fragments that are too large or too long.*

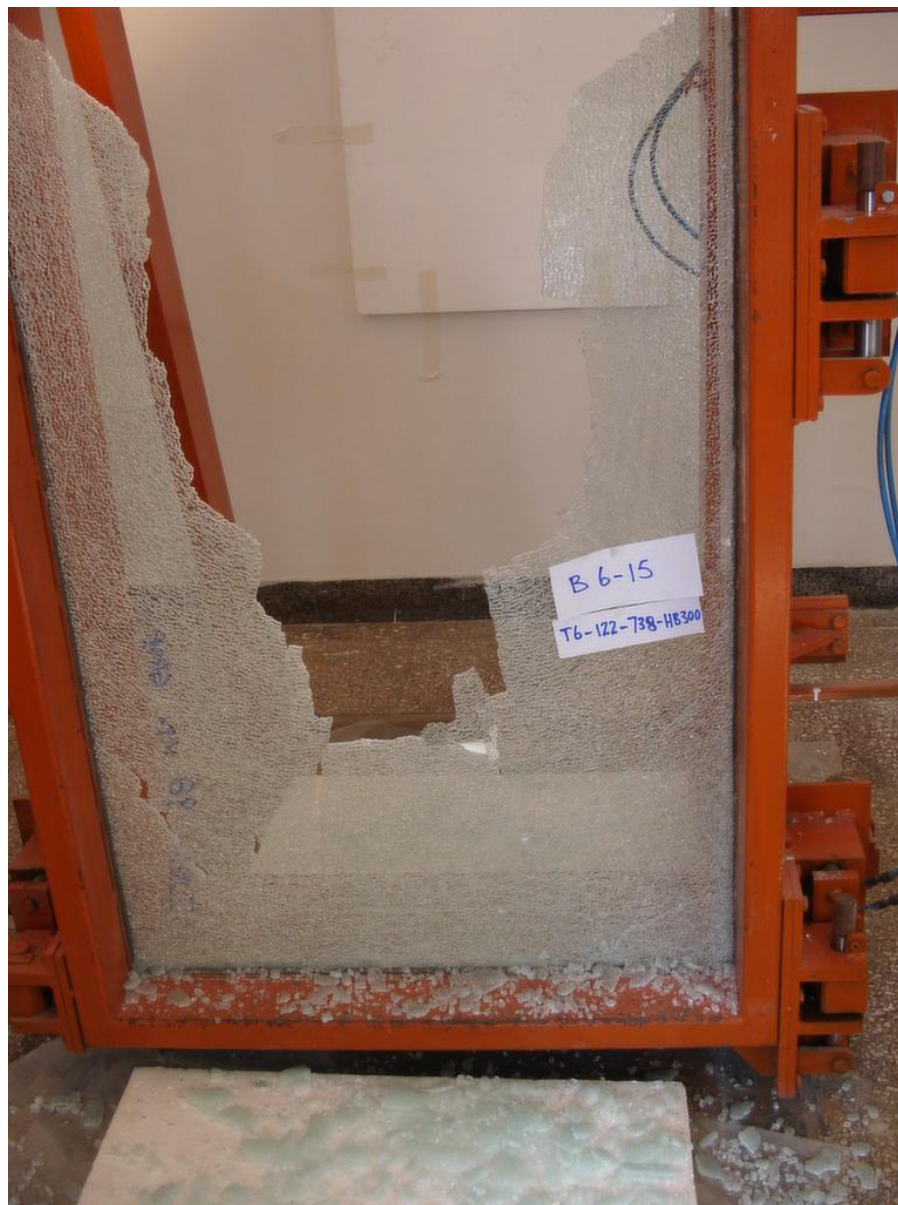
# 6 mm Toughened Panel B6-15

Good fragmentation  
No splines

T6-122-738-HB300  
3 Dec 01

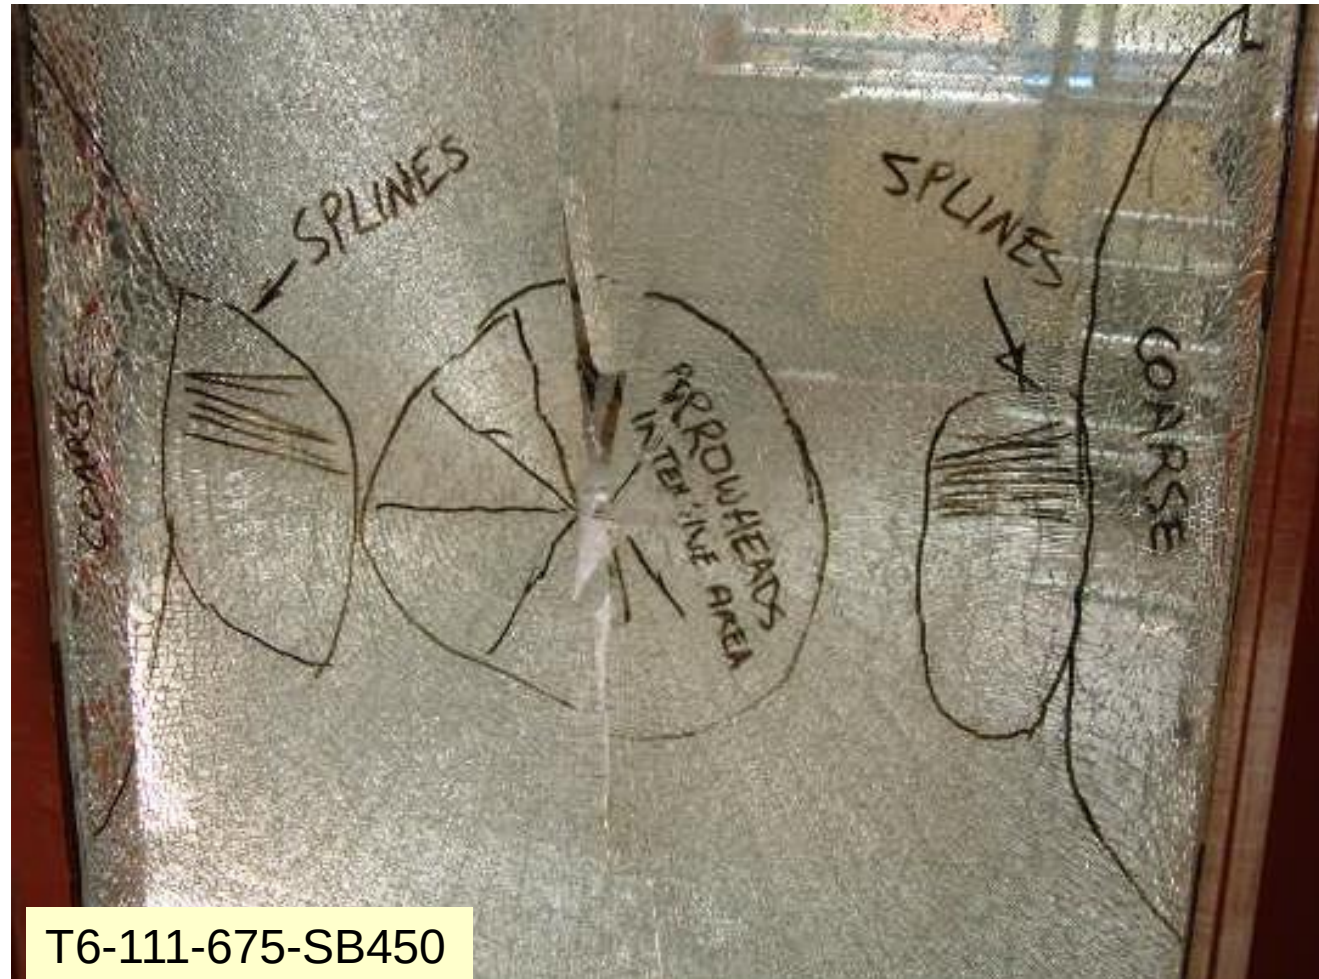
## 6 mm Panel S 6-1-5

Manufacturer:  
GASP 86 MPa

CSGC:  
GASP 94 MPa  
DSR 105 MPa

T6-111-675-SB450

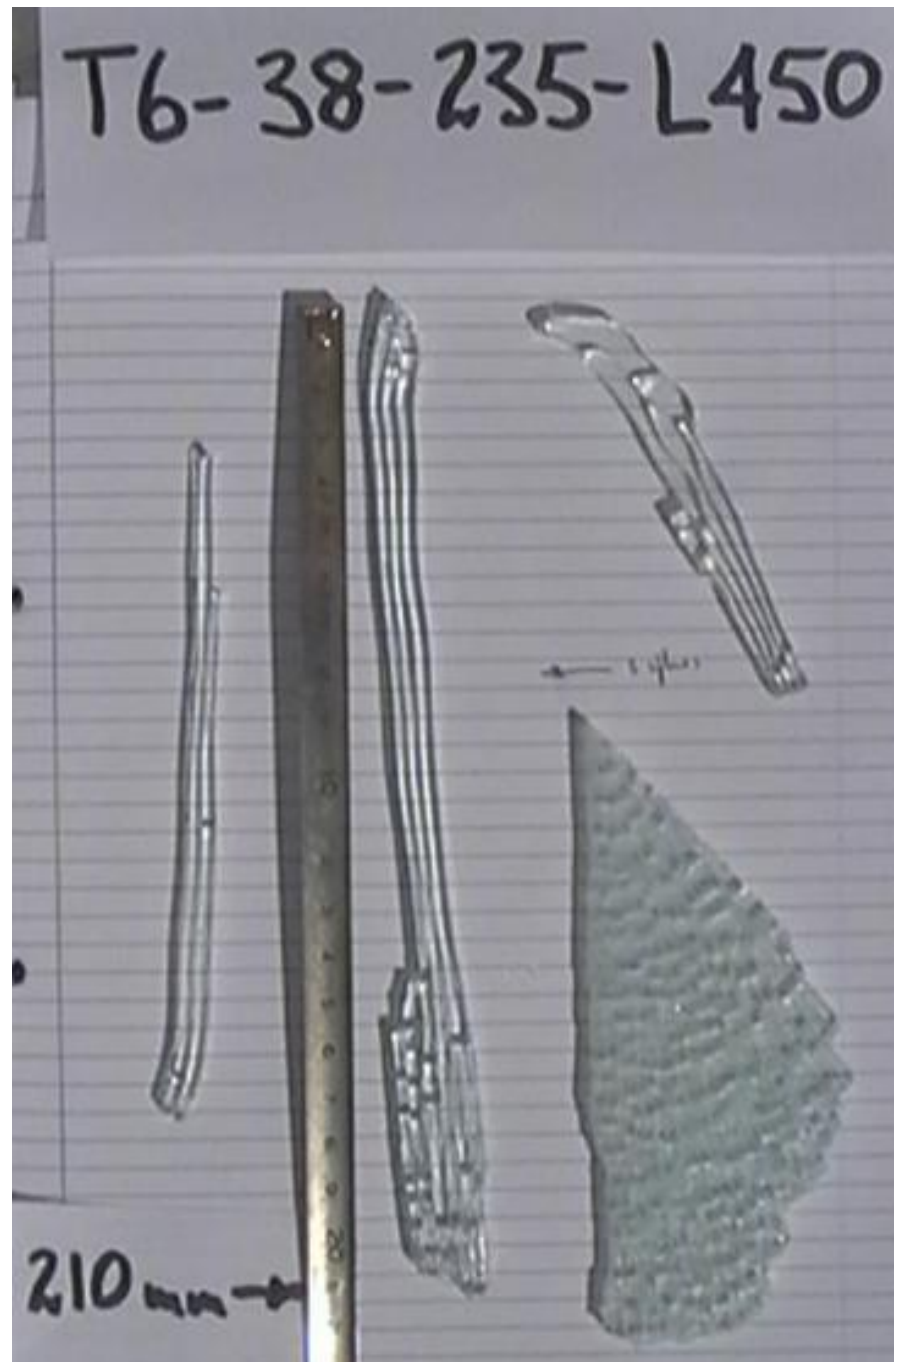
## 6 mm Toughened Panel Q 6-2

Surface compression:  
DSR 99 MPa

Impactor:  
ANSI Z97.1 Everlast® 4212 LSB  
Drop Height: 450 mm

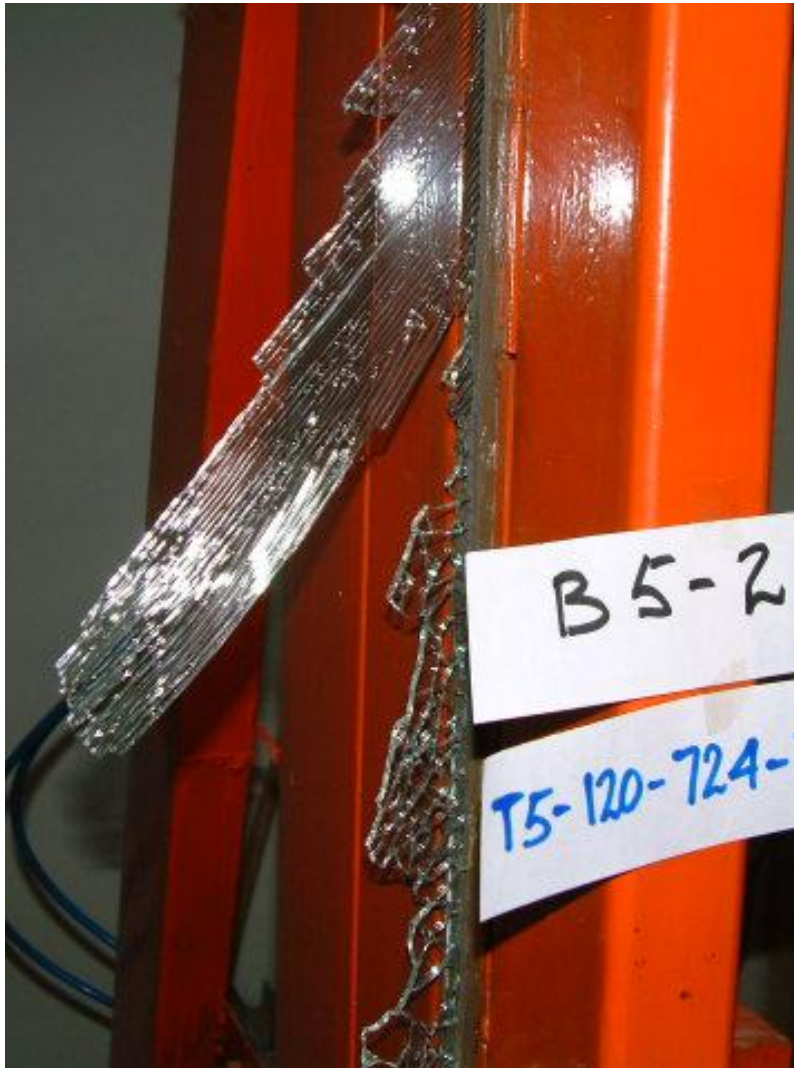
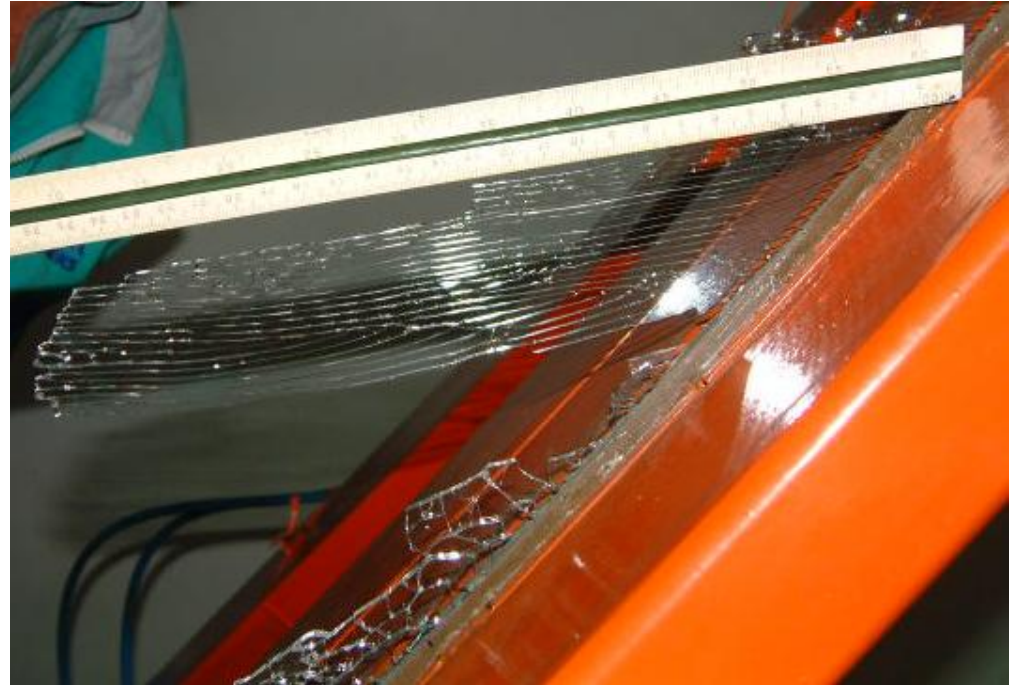
# 5 mm Toughened Panel B 5-2 – Splines

876mm x 1938mm

Surface compression:

GASP 91 MPa

Broken by EN12600 TT Impactor

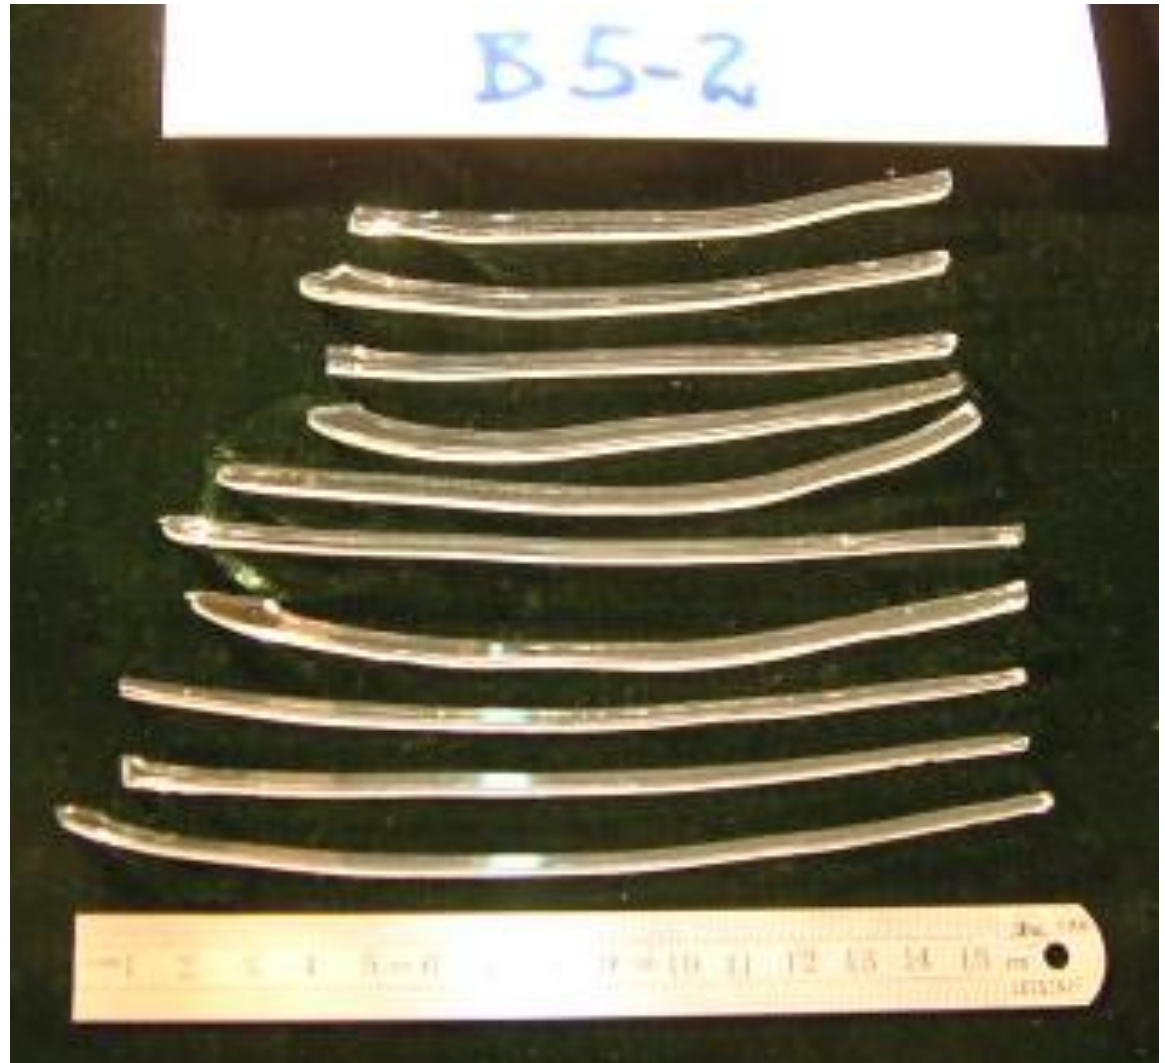
Scratch imparted to panel  
centre

CSGC Test Program  
December 2001

Weight of 10 largest crack-free particles: 44 grams (versus 78.5 grams permitted)

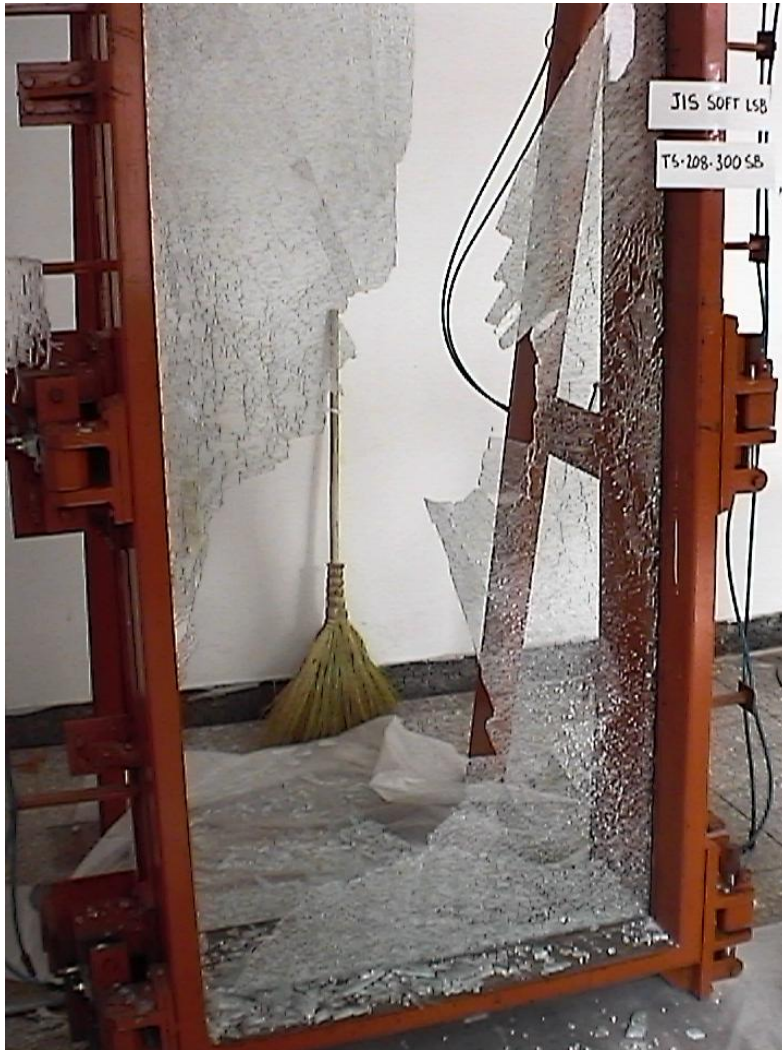
# 5 mm Toughened Glass Pendulum Impact Test Result

**T5-203**  
**Result of impact from**  
**450 mm with JIS LSB**

***The splines on the ground and remaining in the frame are similar to those found with panel T5-218 which was centre punched at the panel centre..***

**Surface compression**  
**108 MPa**

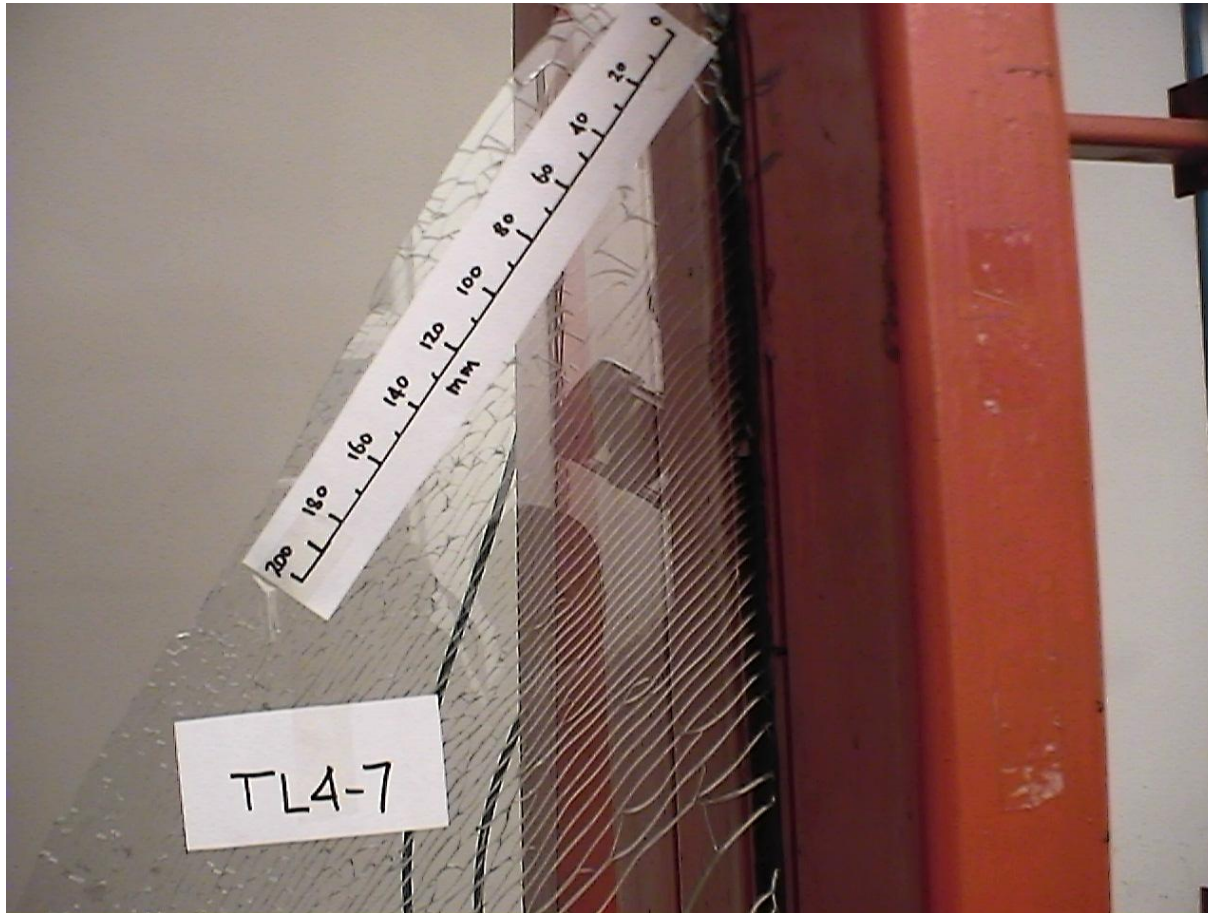
# Long Particles – Pendulum Impact Test

4 mm Toughened Glass (TL4-7 Feb 04) – Surface compression 86 MPa

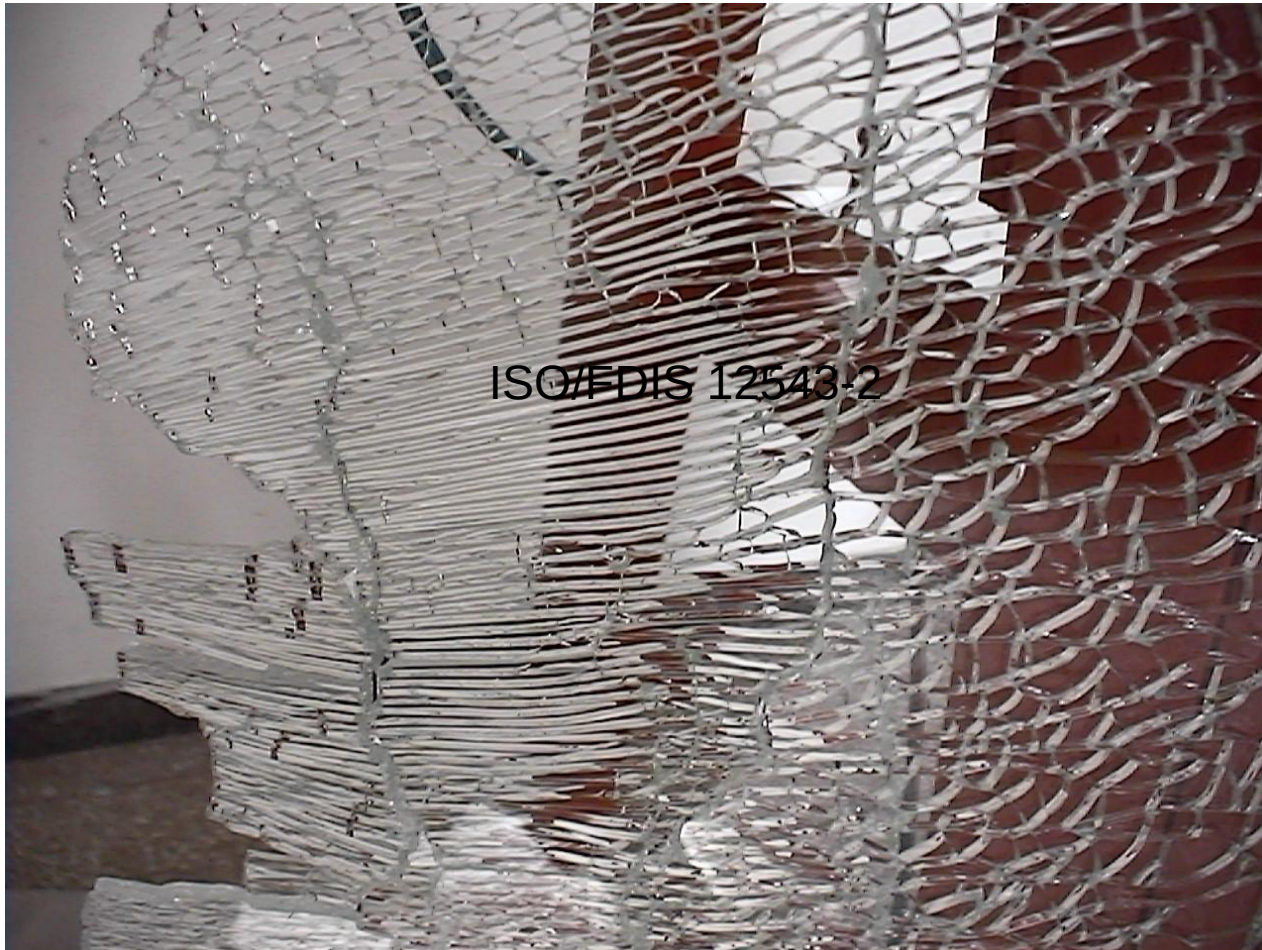
# Fracture Pattern

5 mm Toughened Glass SC 110 MPa

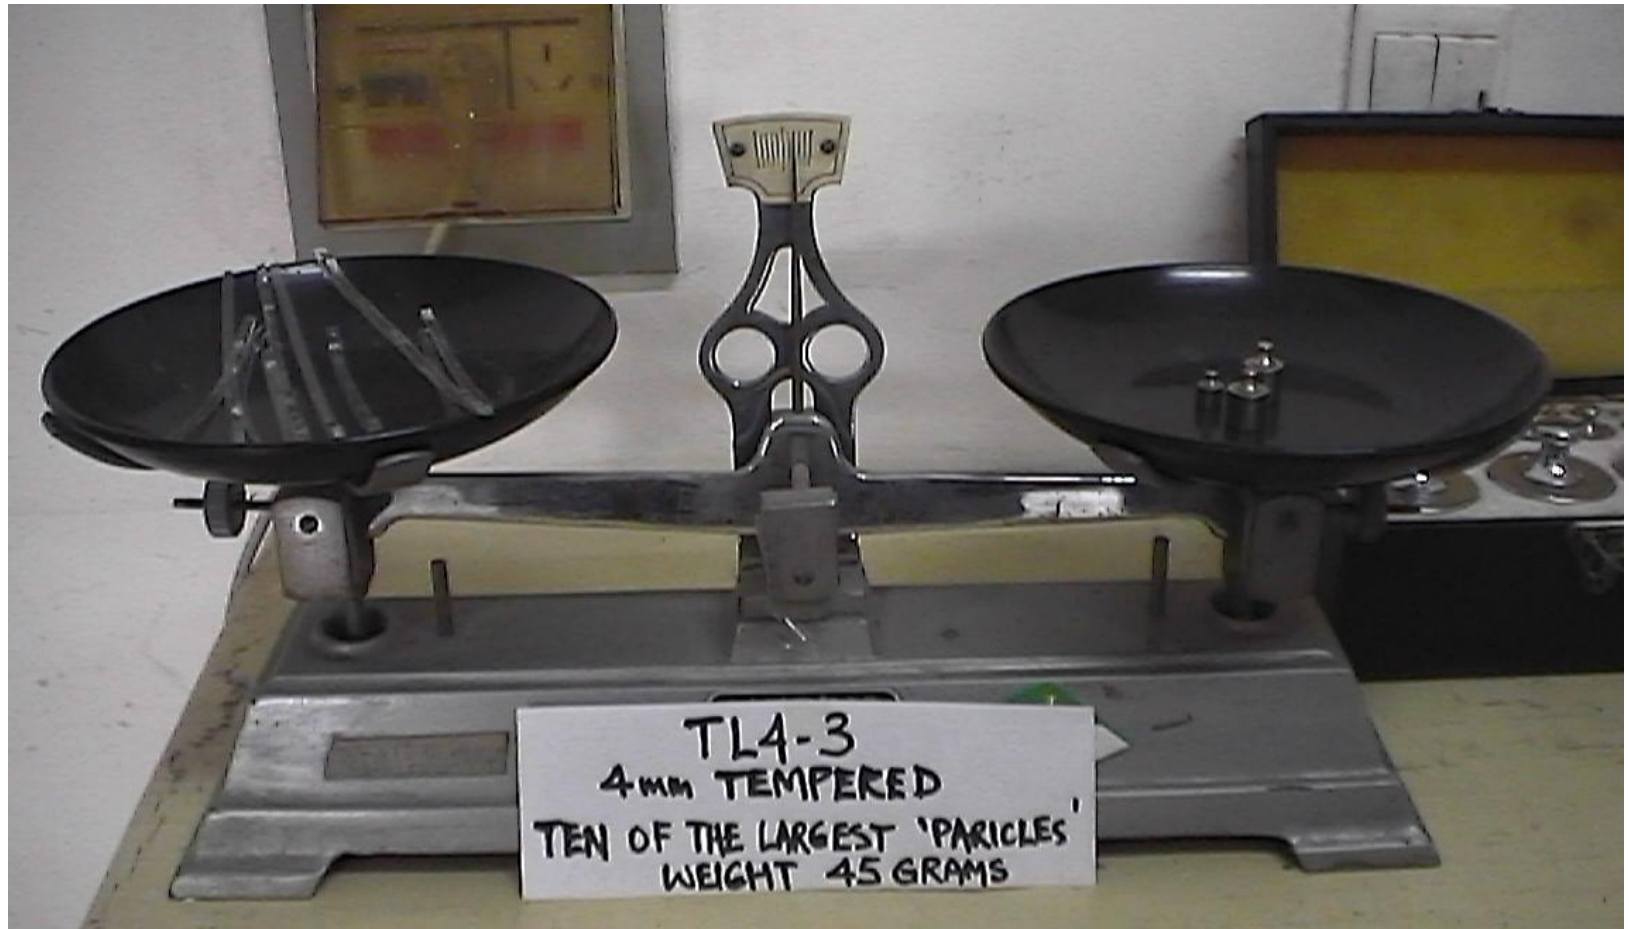
# Weight of 10 Largest 'Crack-Free' Particles

Maximum weight permitted for 'Pass' classification – 65 grams

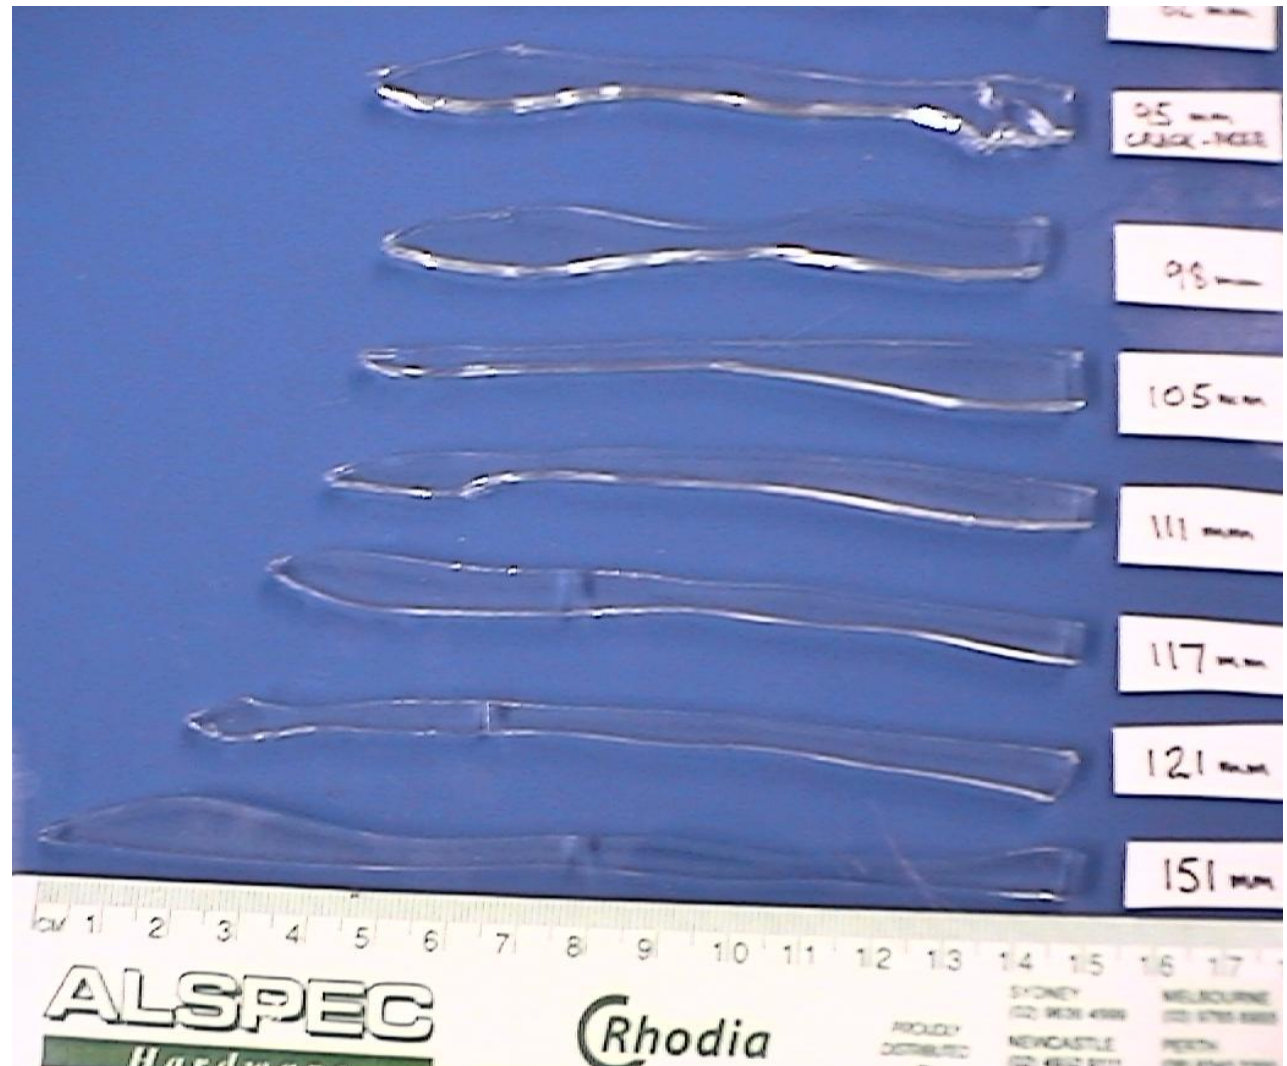
## **Long Particles - EN 12150\***

5 mm Toughened Glass was produced at the Mfr's standard conditions.

Particle count (AS 2208) was around 50 versus AS 2208 min. PC of 40

A panel punched at the panel centre produced these 'splines'.

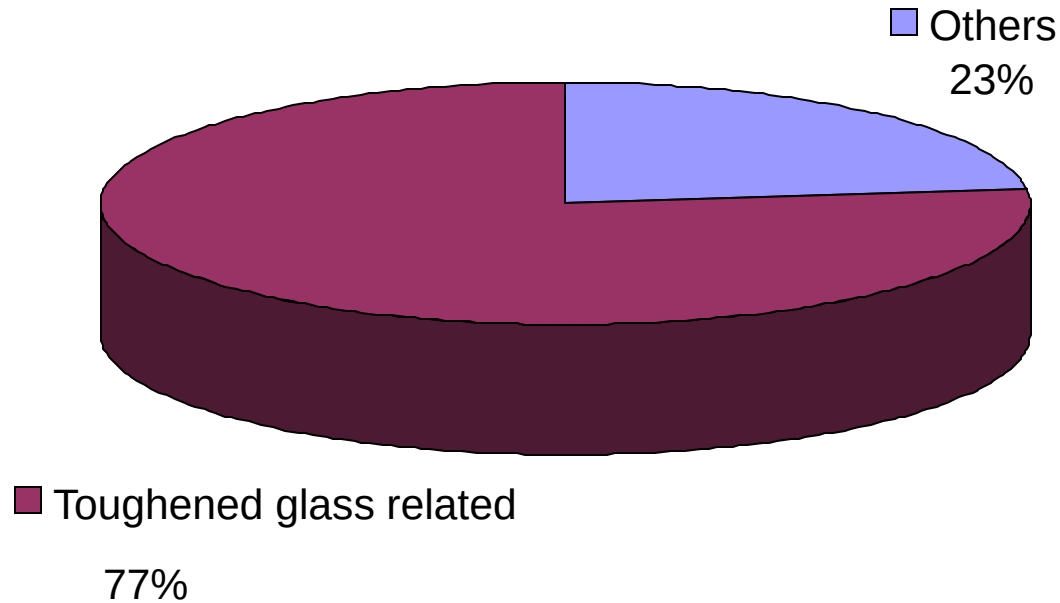
# Bathtub & Shower Enclosures - CPSC Reported Incidents

**26% of toughed glass related Incidents caused injuries**

**146 Reported incidents – 1980 to 2002**

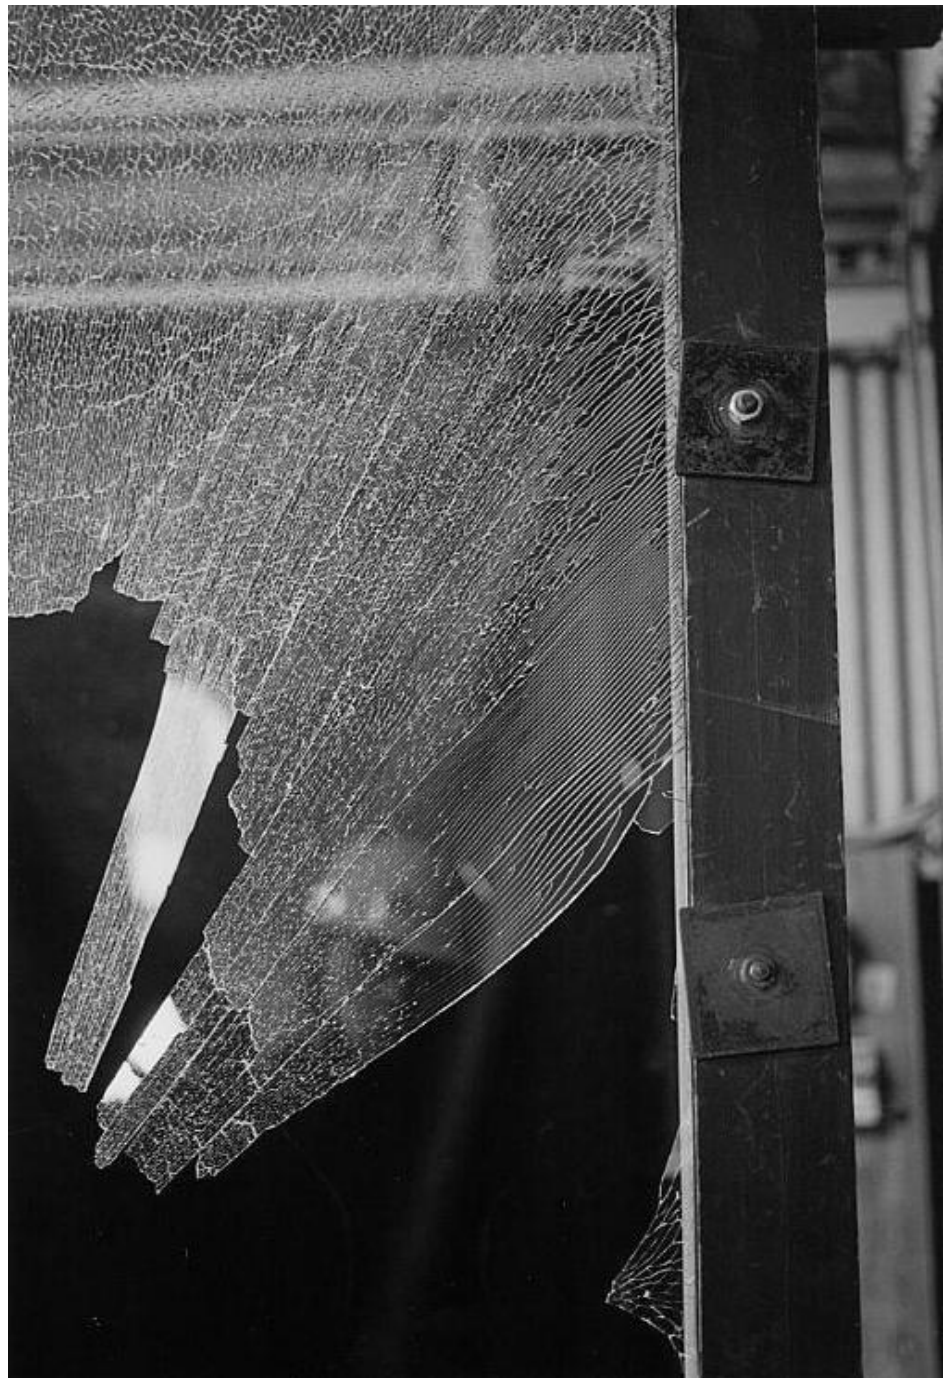
Lead Shot Bag

300 mm Drop Height

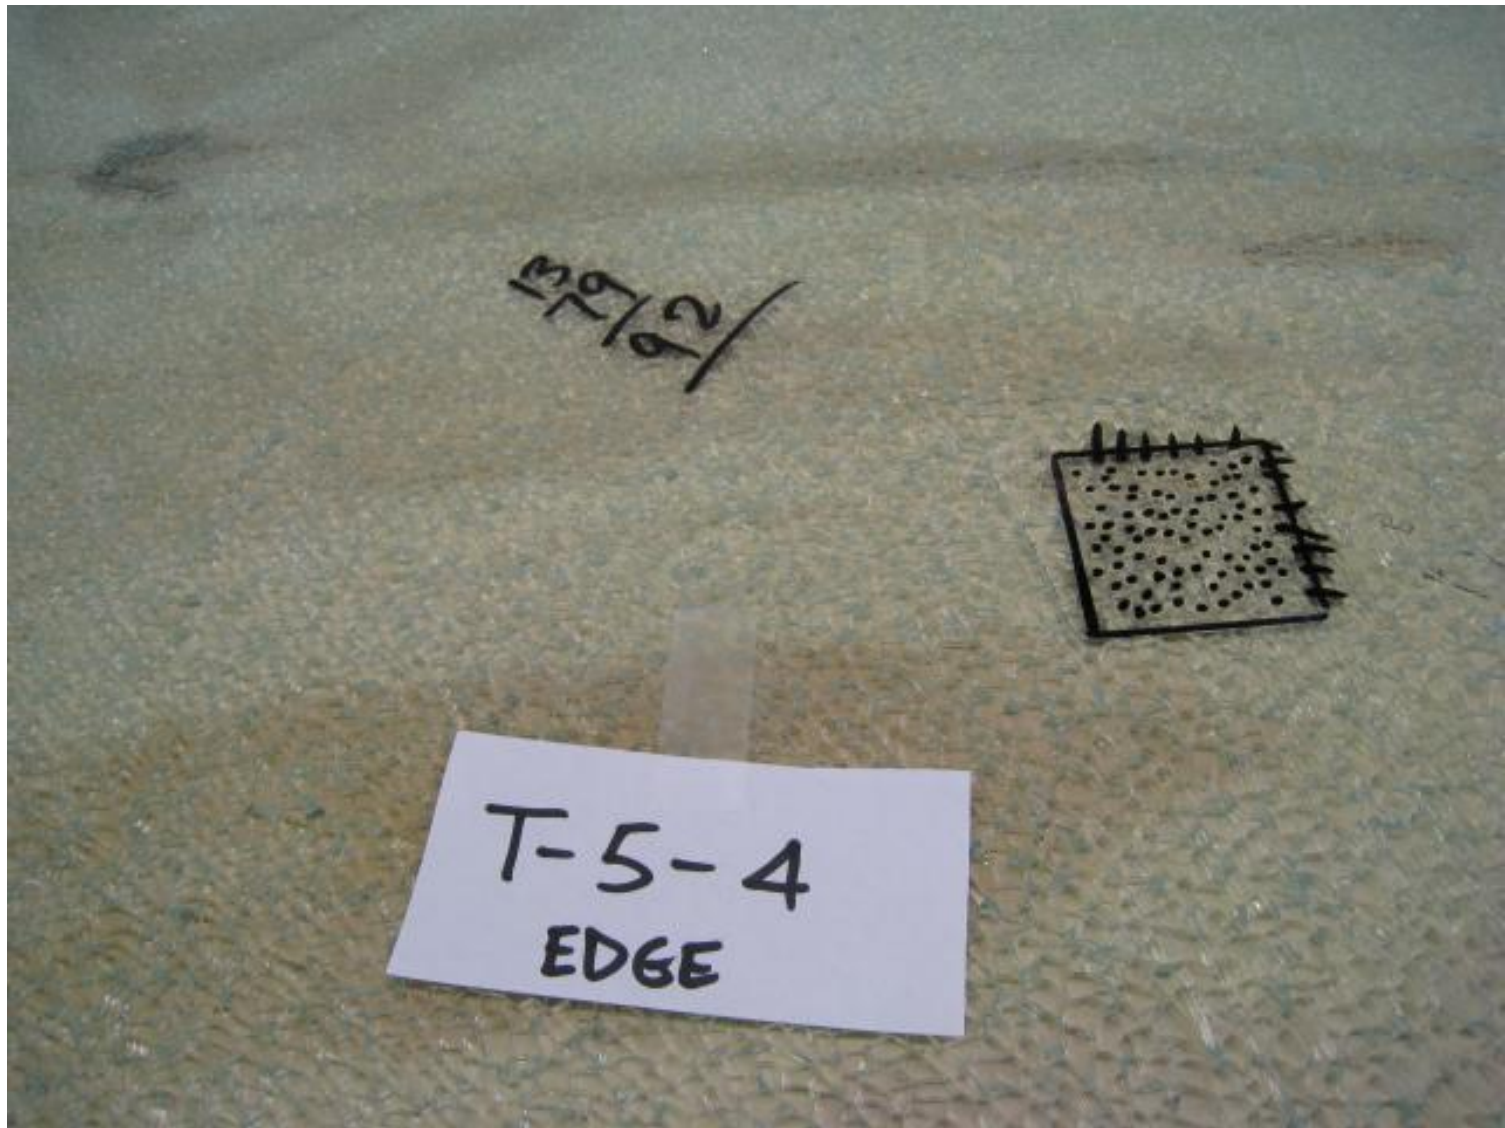
5 mm Sample No.1-4-4; SC 107: Edge Fragmentation - PC 92
