Response to the evidence presented by the Australian Glass and Glazing Association at the February 15, 2016 hearing of the Senate Economics Committee into Non conforming building products.

## **Results, Conclusions and Recommendations Relating to AS/NZS 2208**

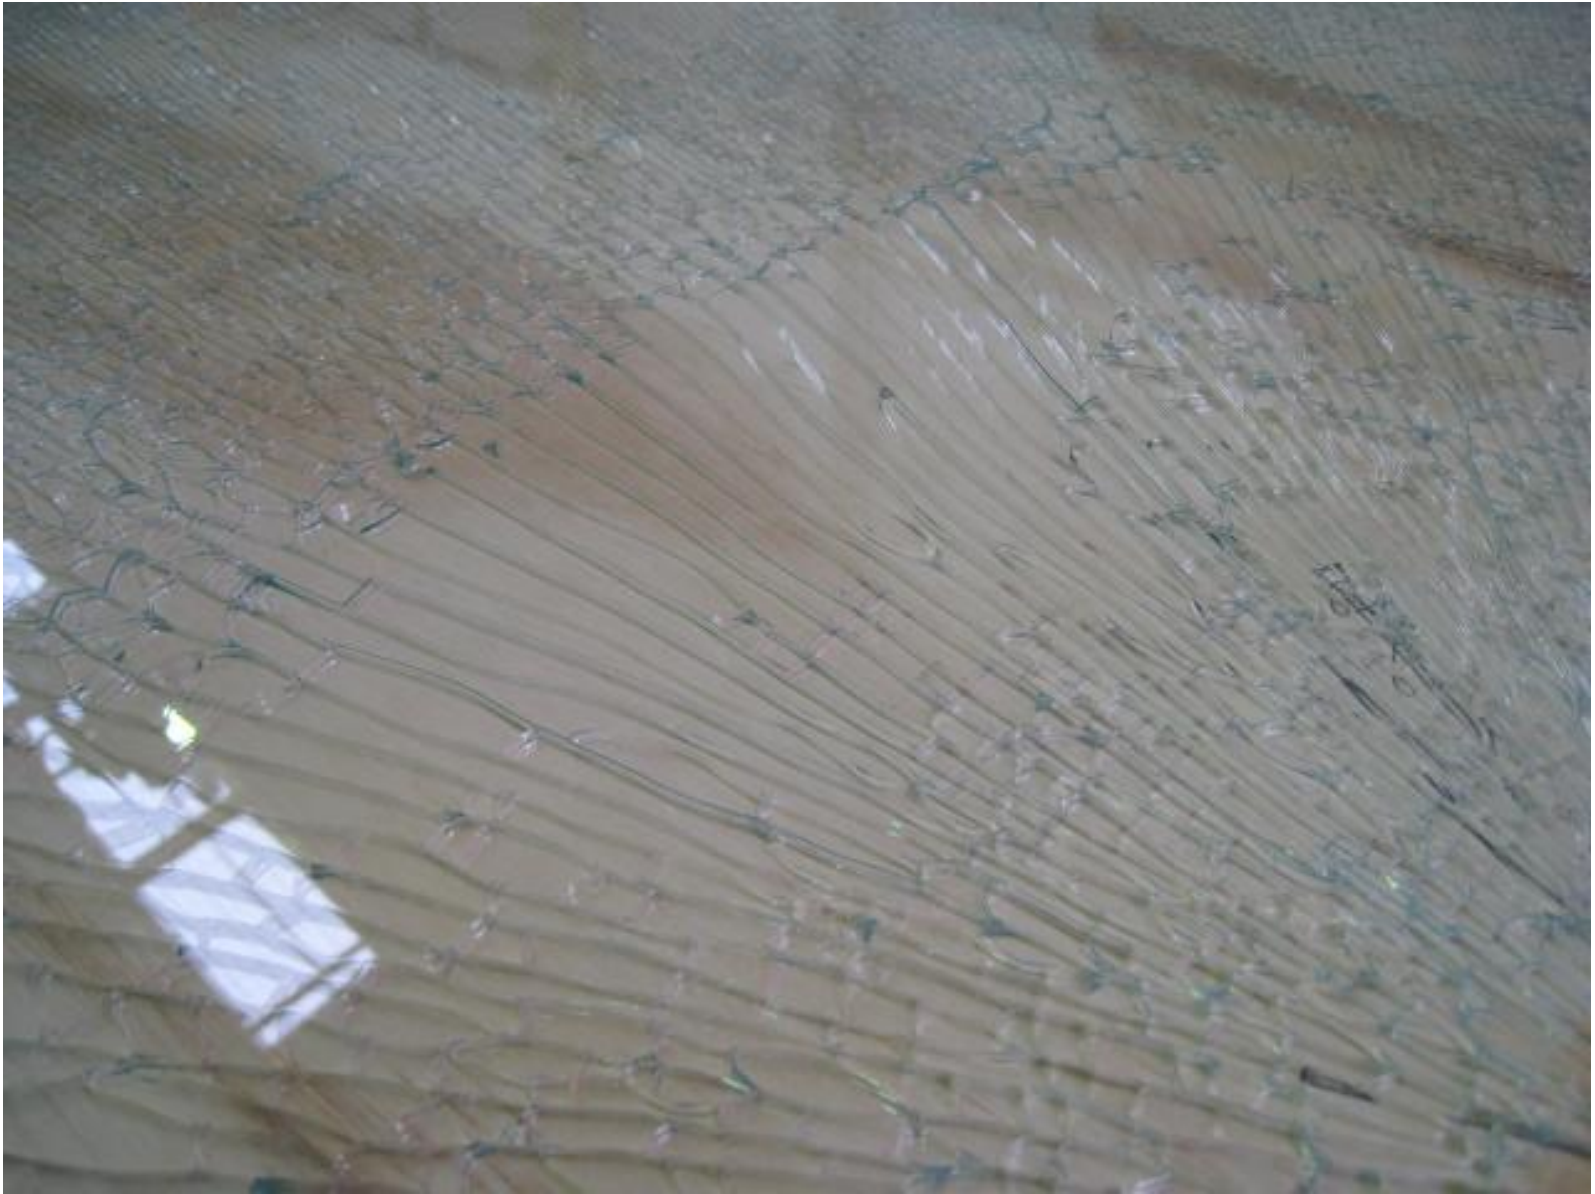
**4 mm Sample No.1\_4-6; SC 113: Centre Fragmentation, Longest Particle 170 mm**

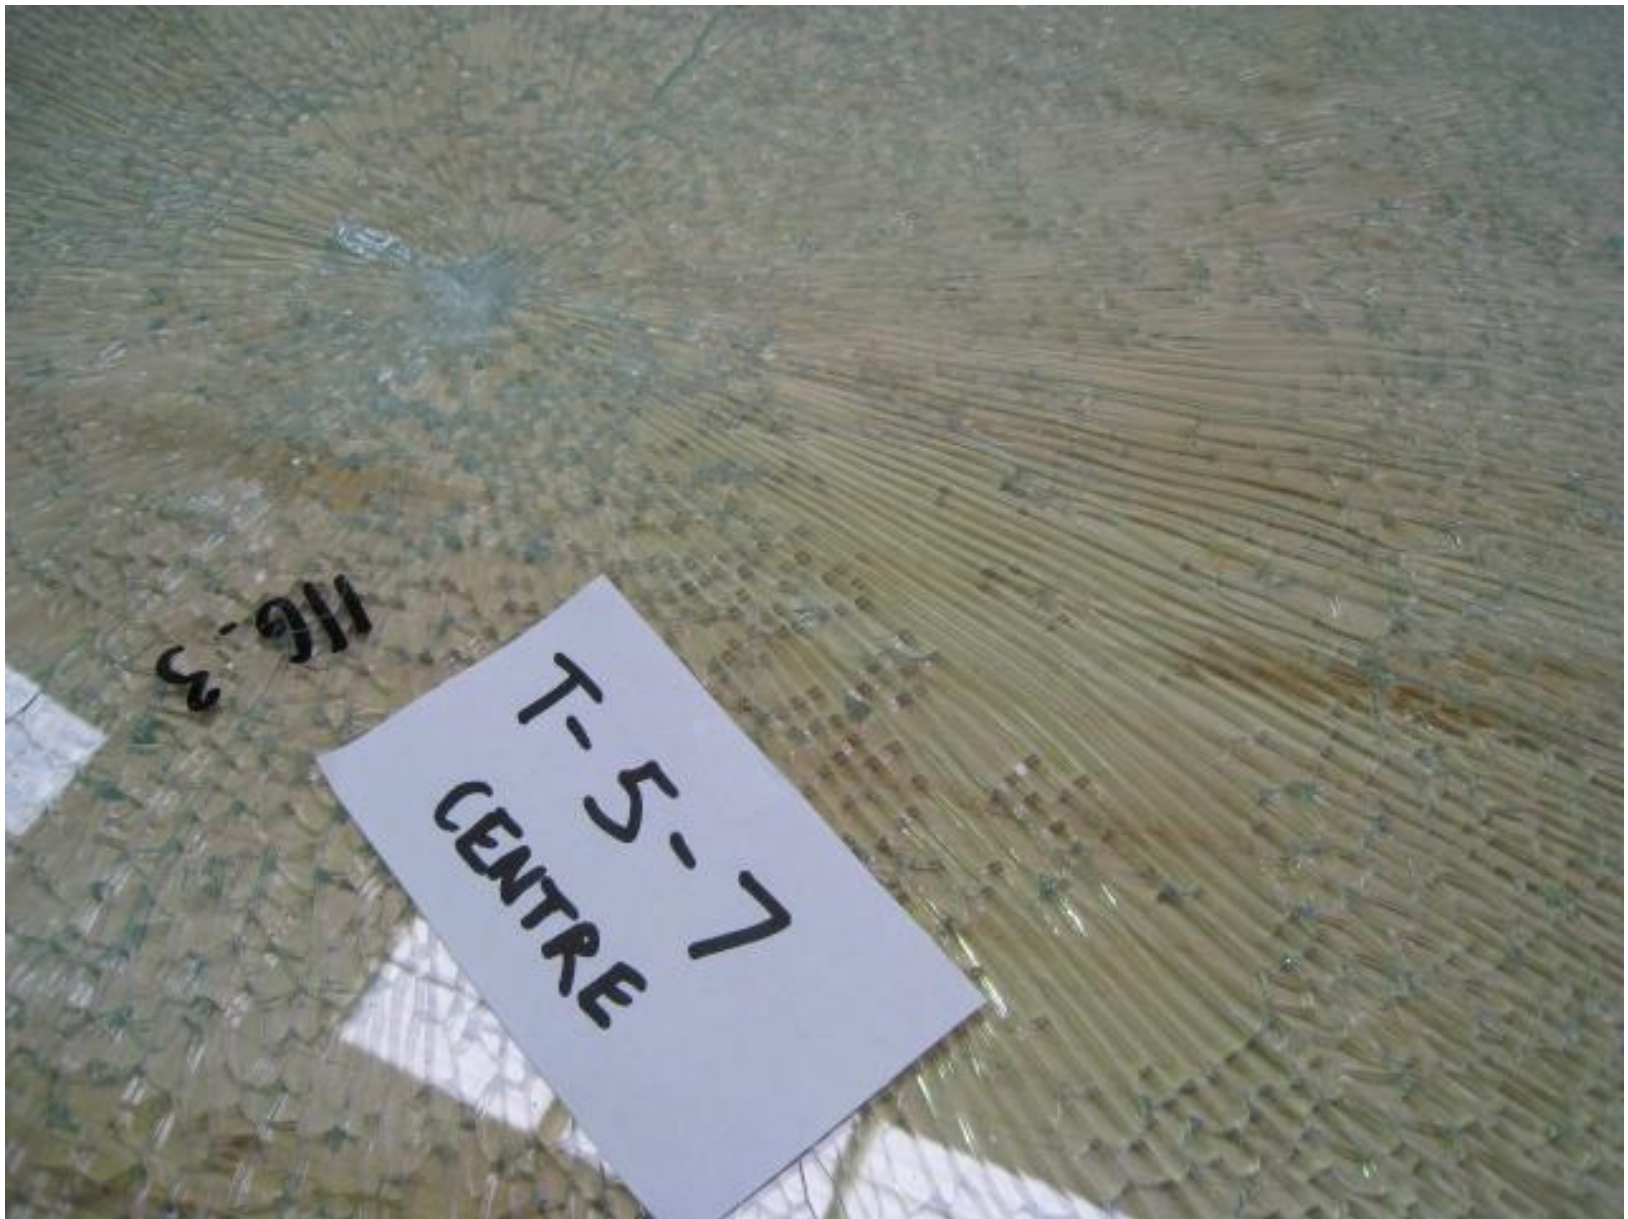
**5 mm Sample No.1\_5-7; SC 116; Centre Fragmentation - Longest Particle 151 mm**

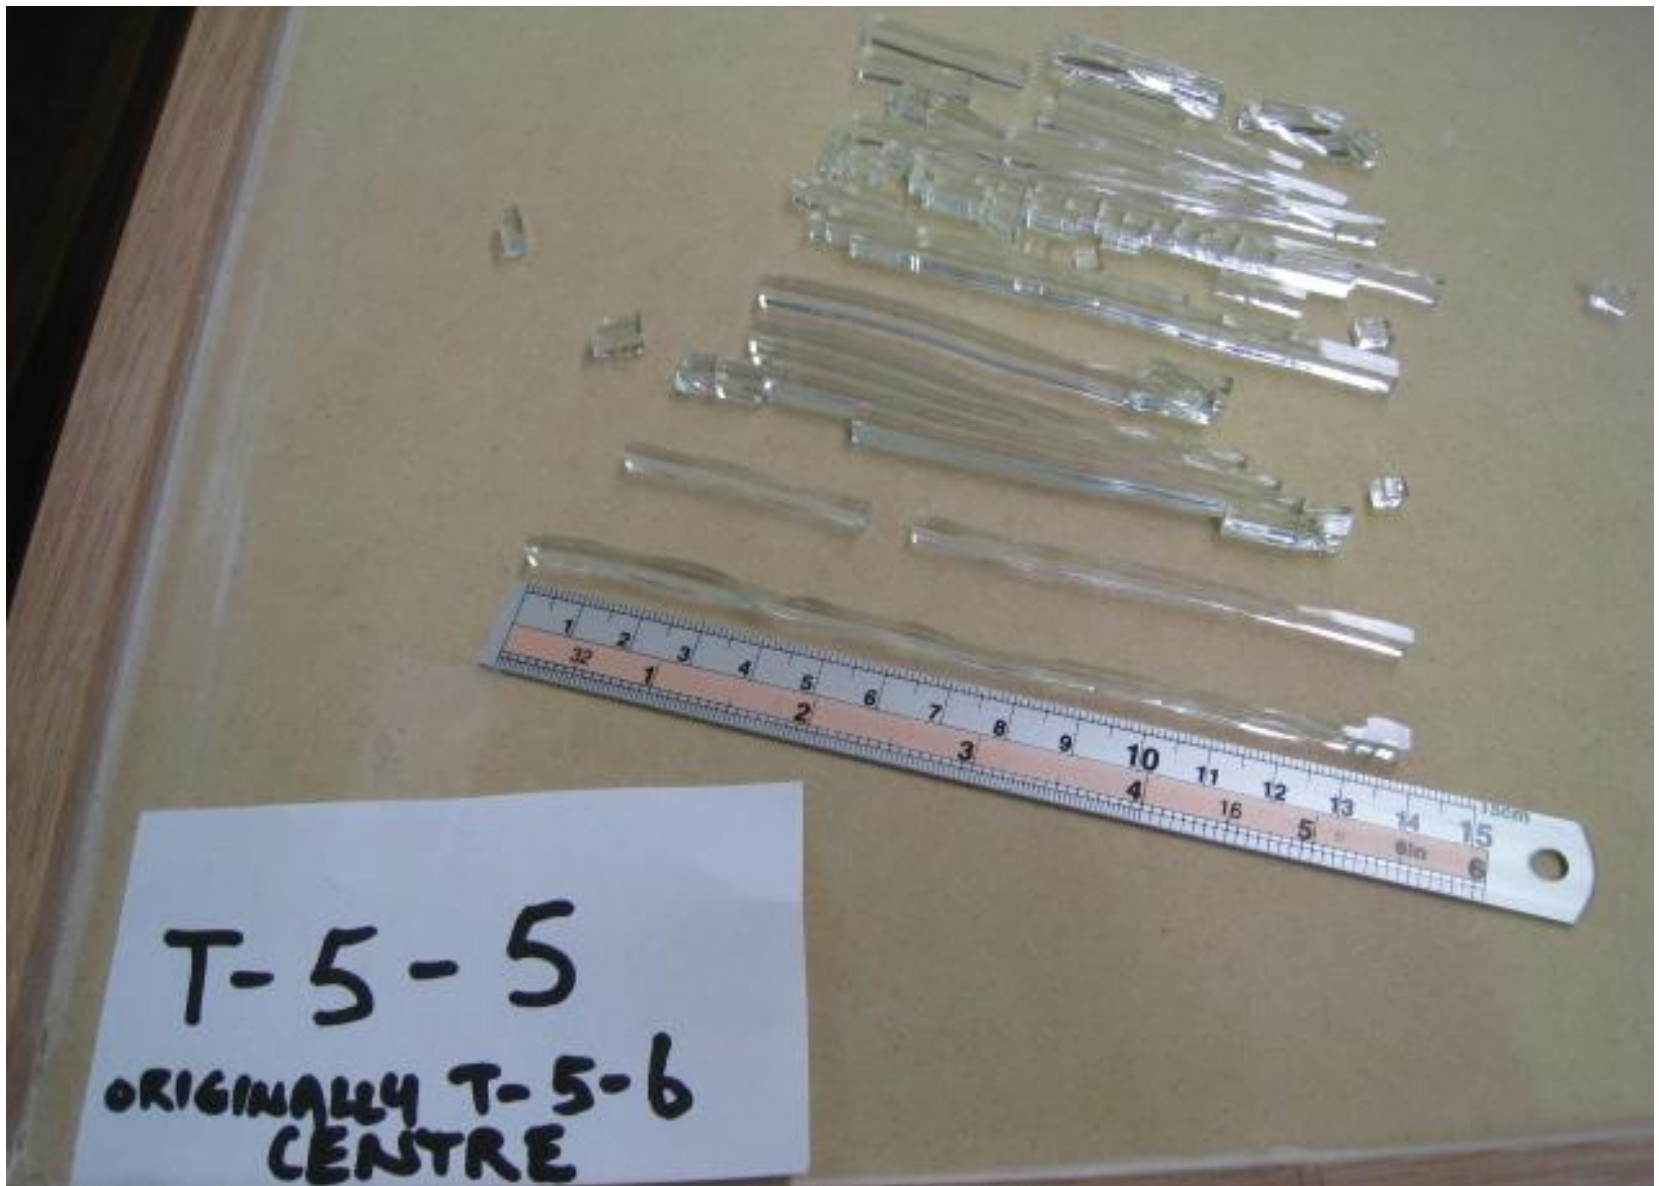
Splines from 5 mm Sample No.1\_5-5; SC 107: Centre Fragmentation

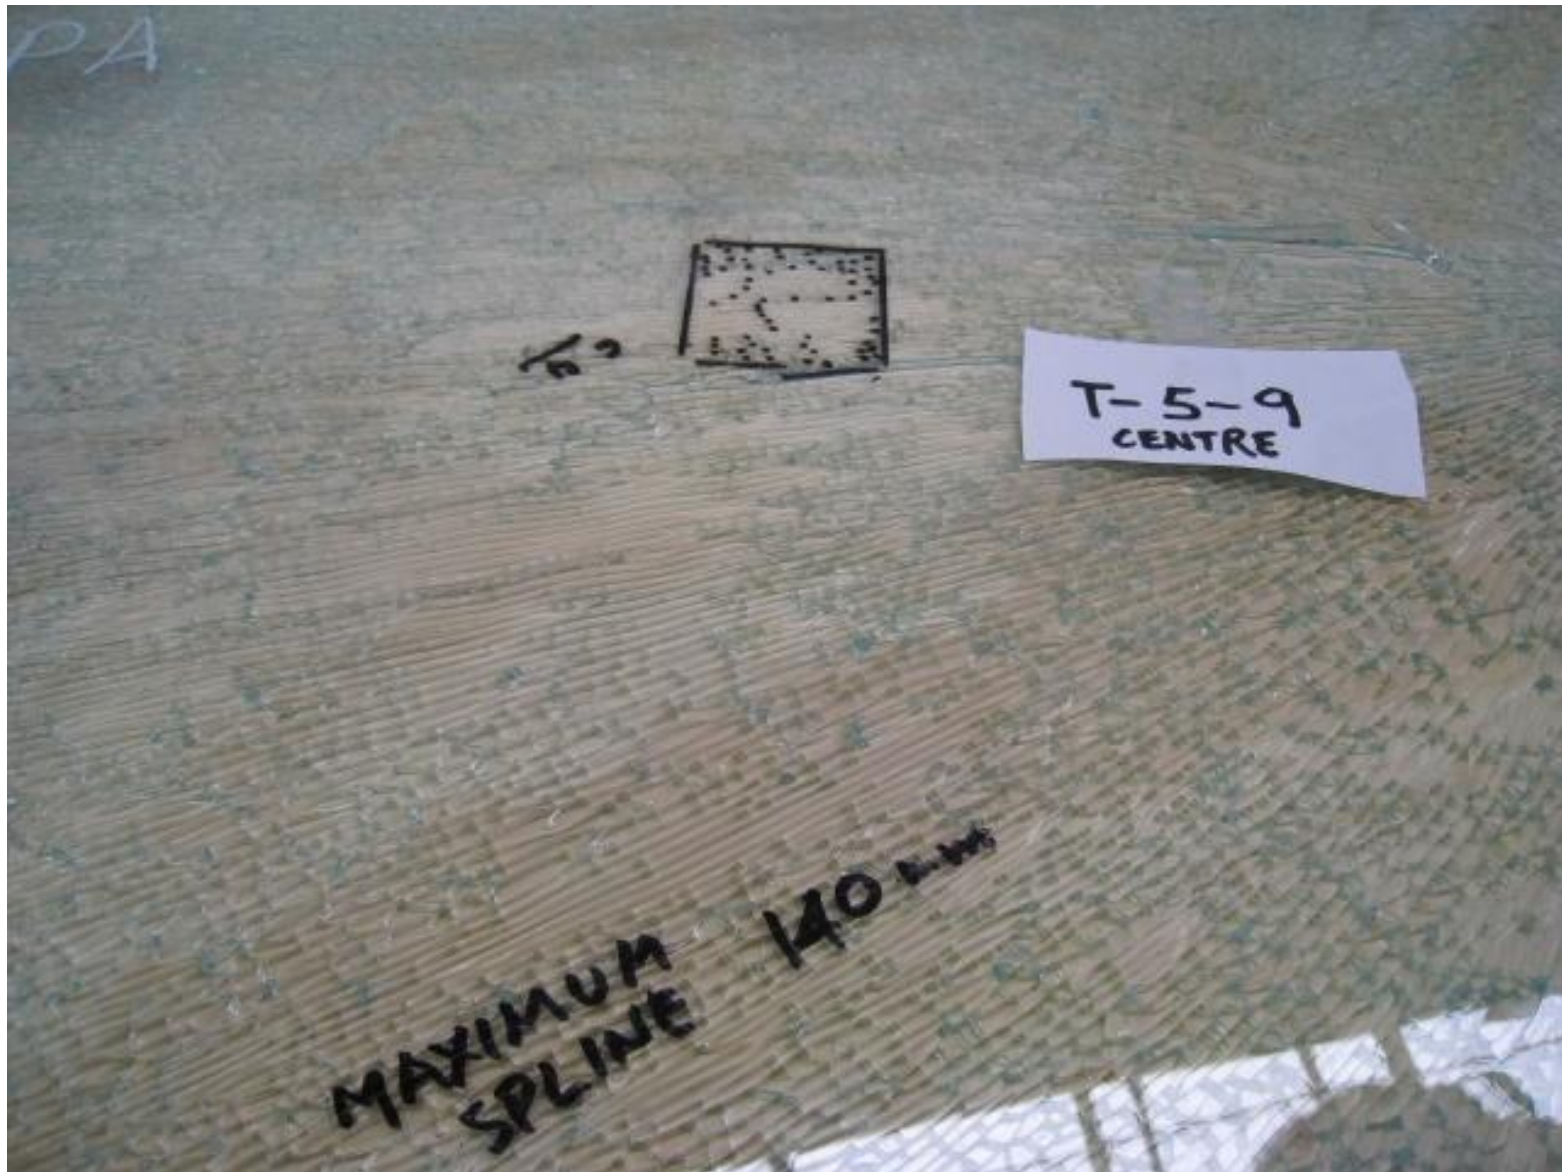
5 mm Sample No. 1\_5-9; SC 114: Centre Fragmentation – Longest Particle 140 mm

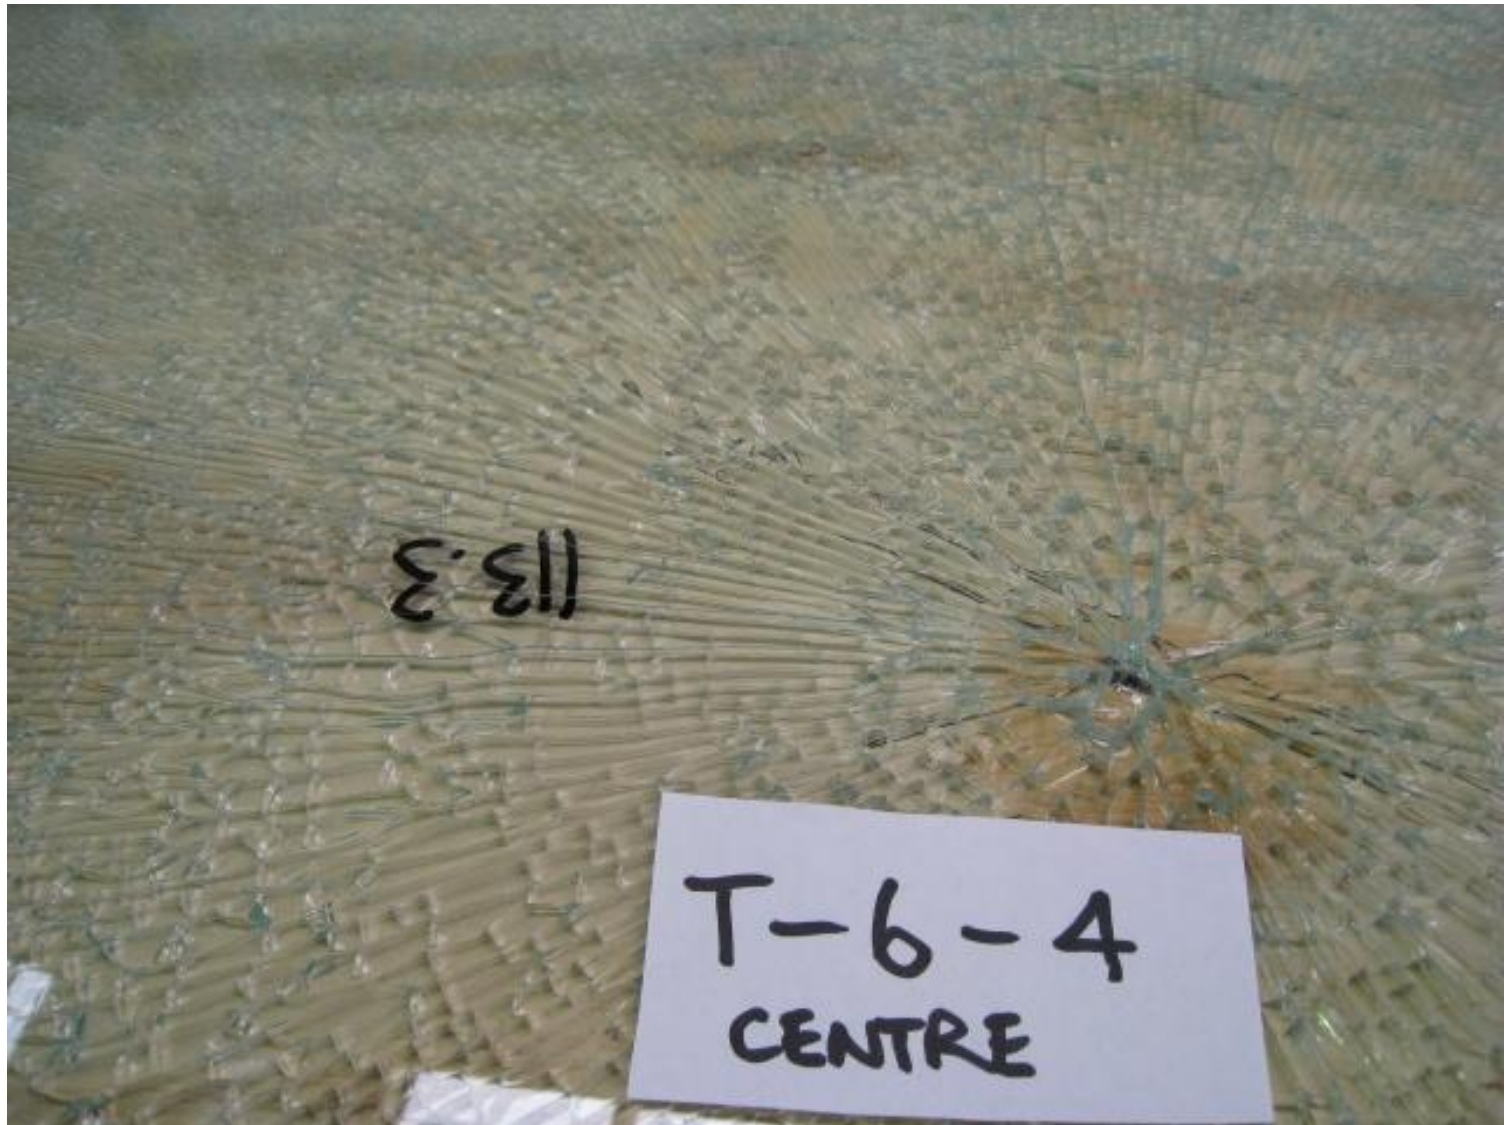
6 mm Sample No. 1\_6-4; SC 113: Centre Fragmentation - Longest Particle 100 mm

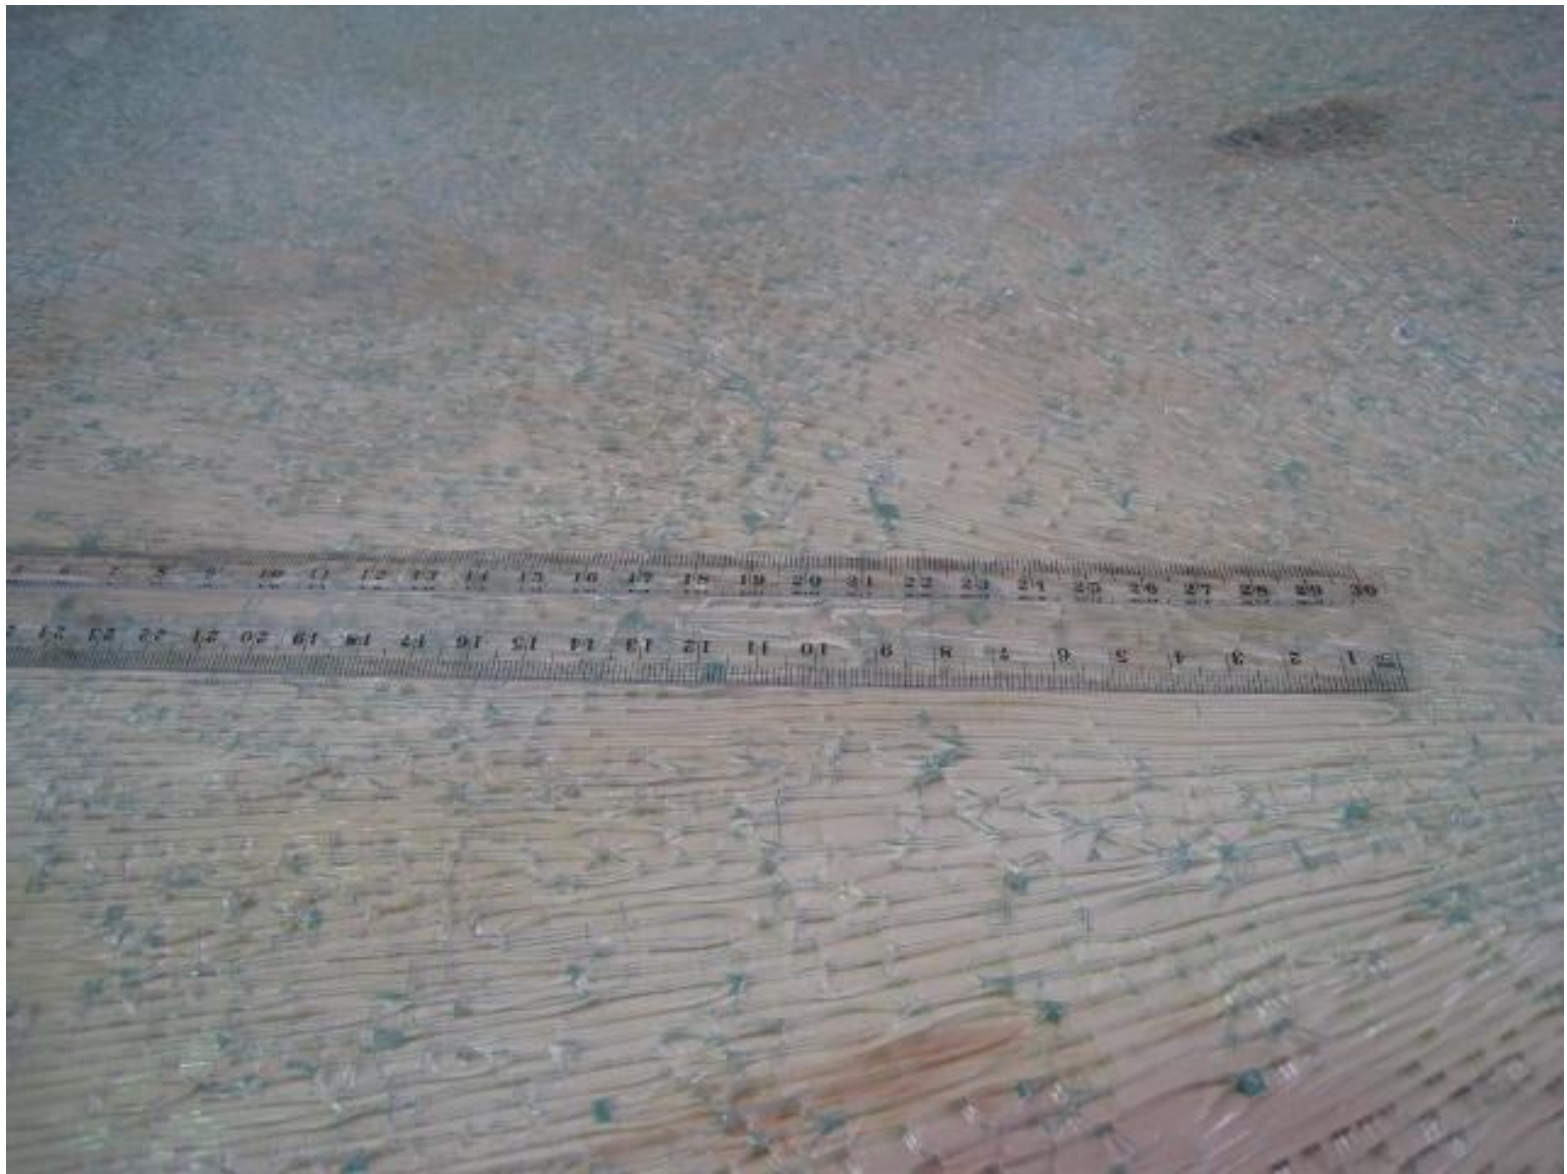
**5 mm Sample No. 1\_5-1; SC 115: Centre Fragmentation - Longest Particle 135 mm**

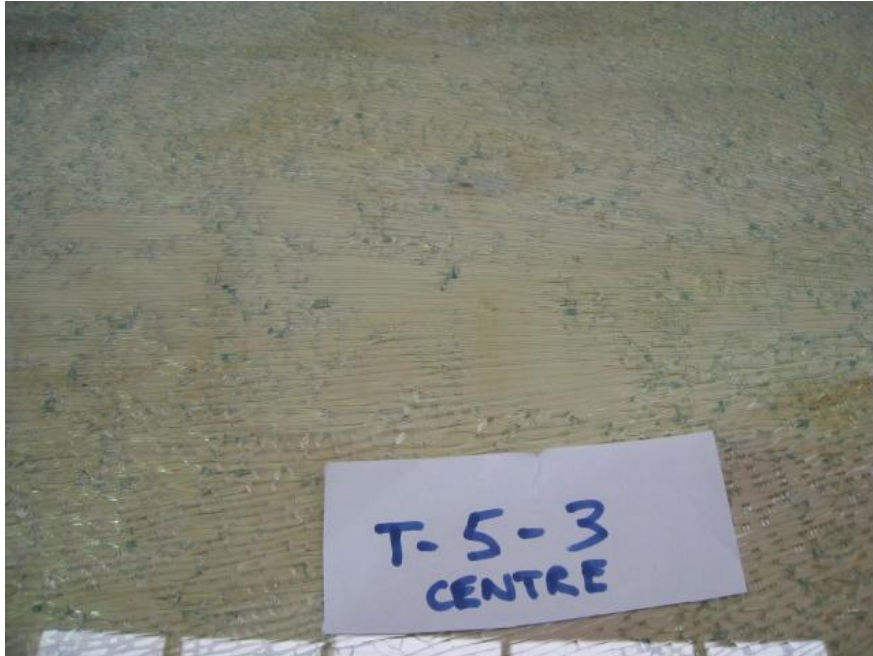
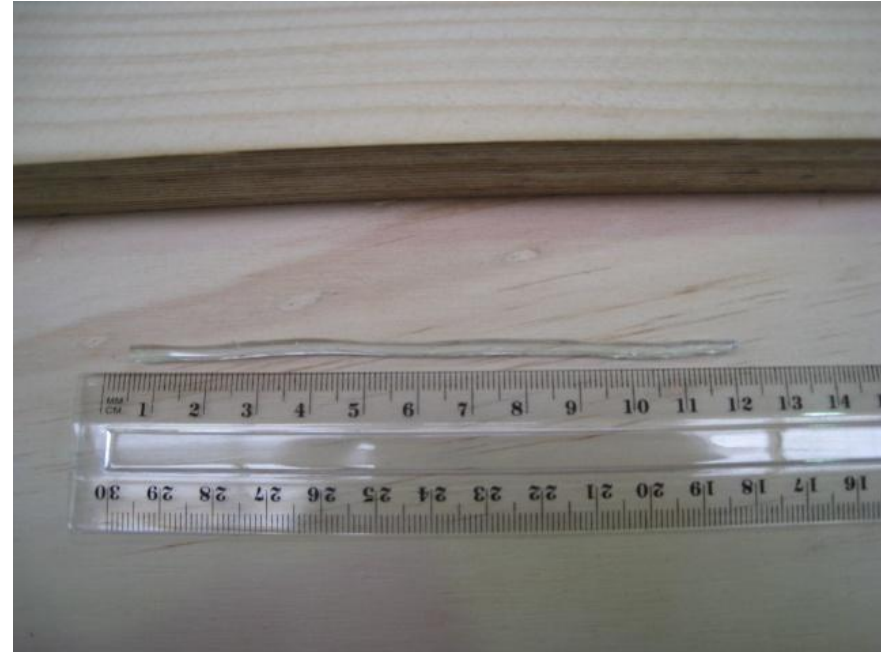
**5 mm Sample 1\_5-3: SC 107: Centre Fragmentation – Longest Particle 140 mm**

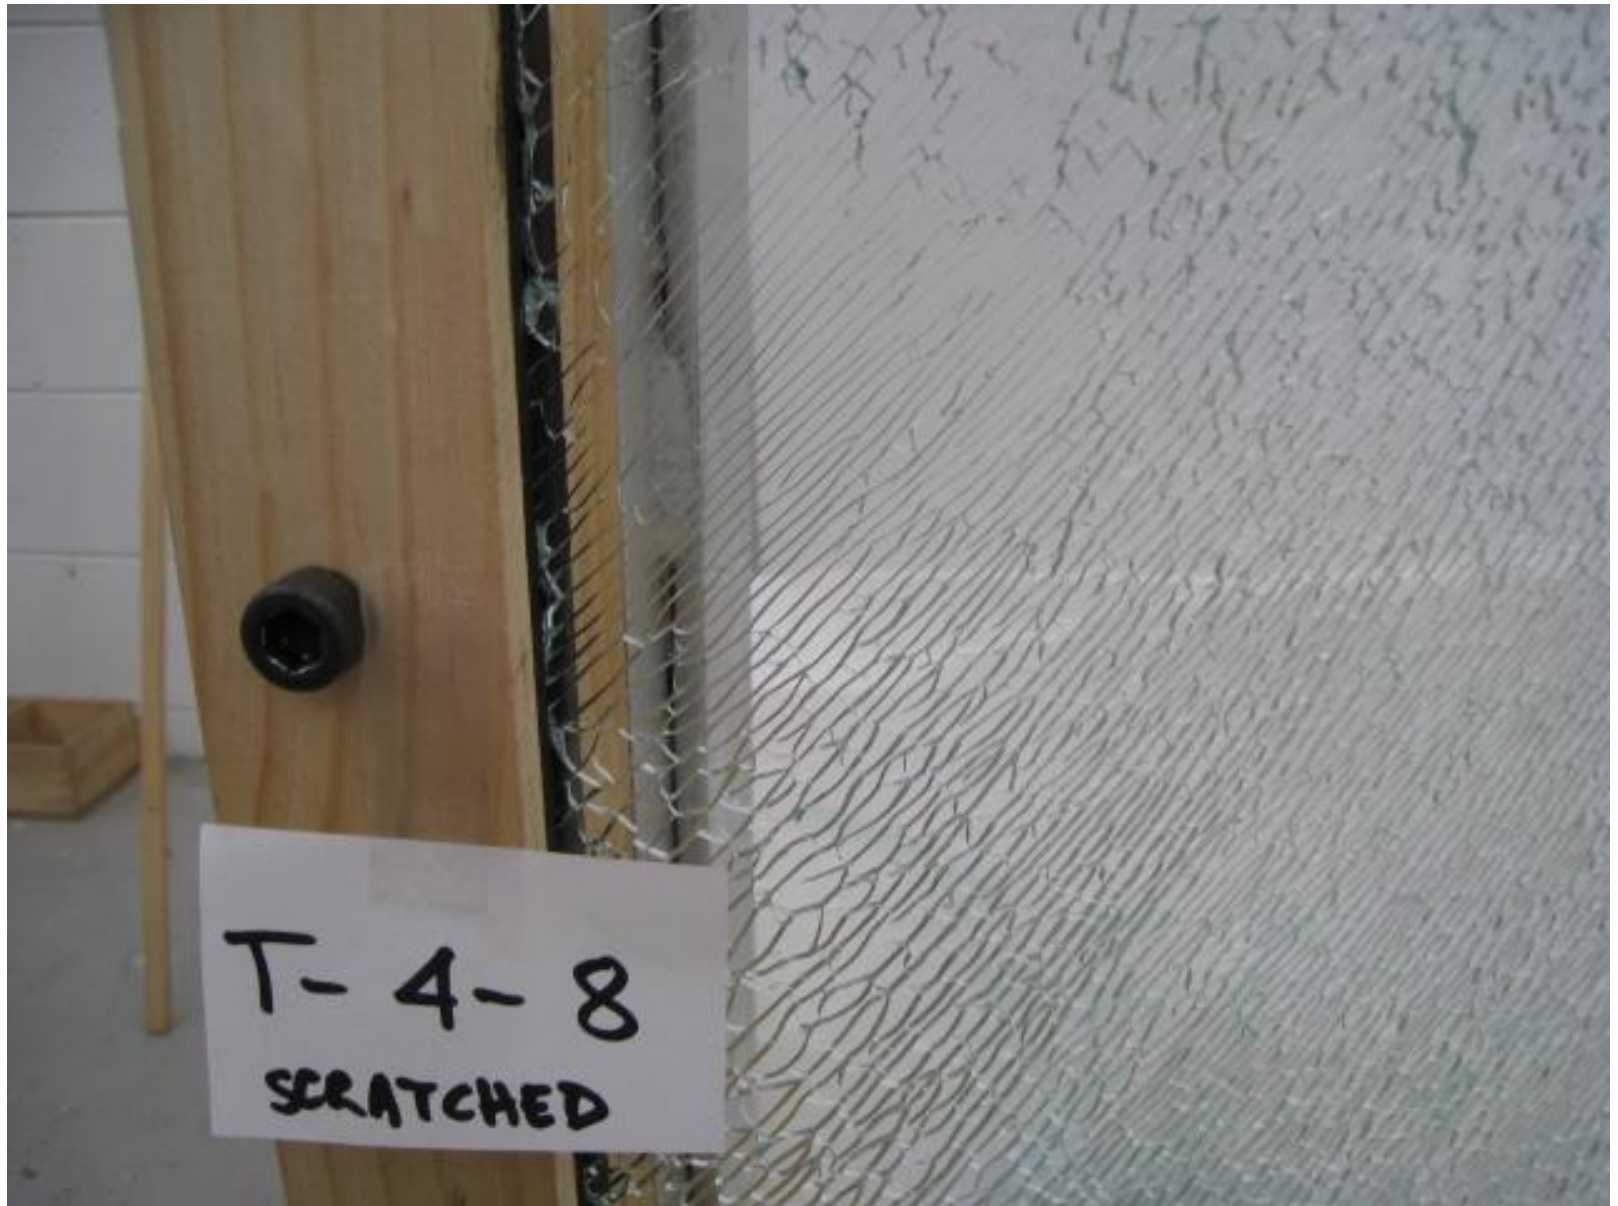
**4 mm Sample No.1\_4-8; SC 100 MPa: LSB - Glass in frame**

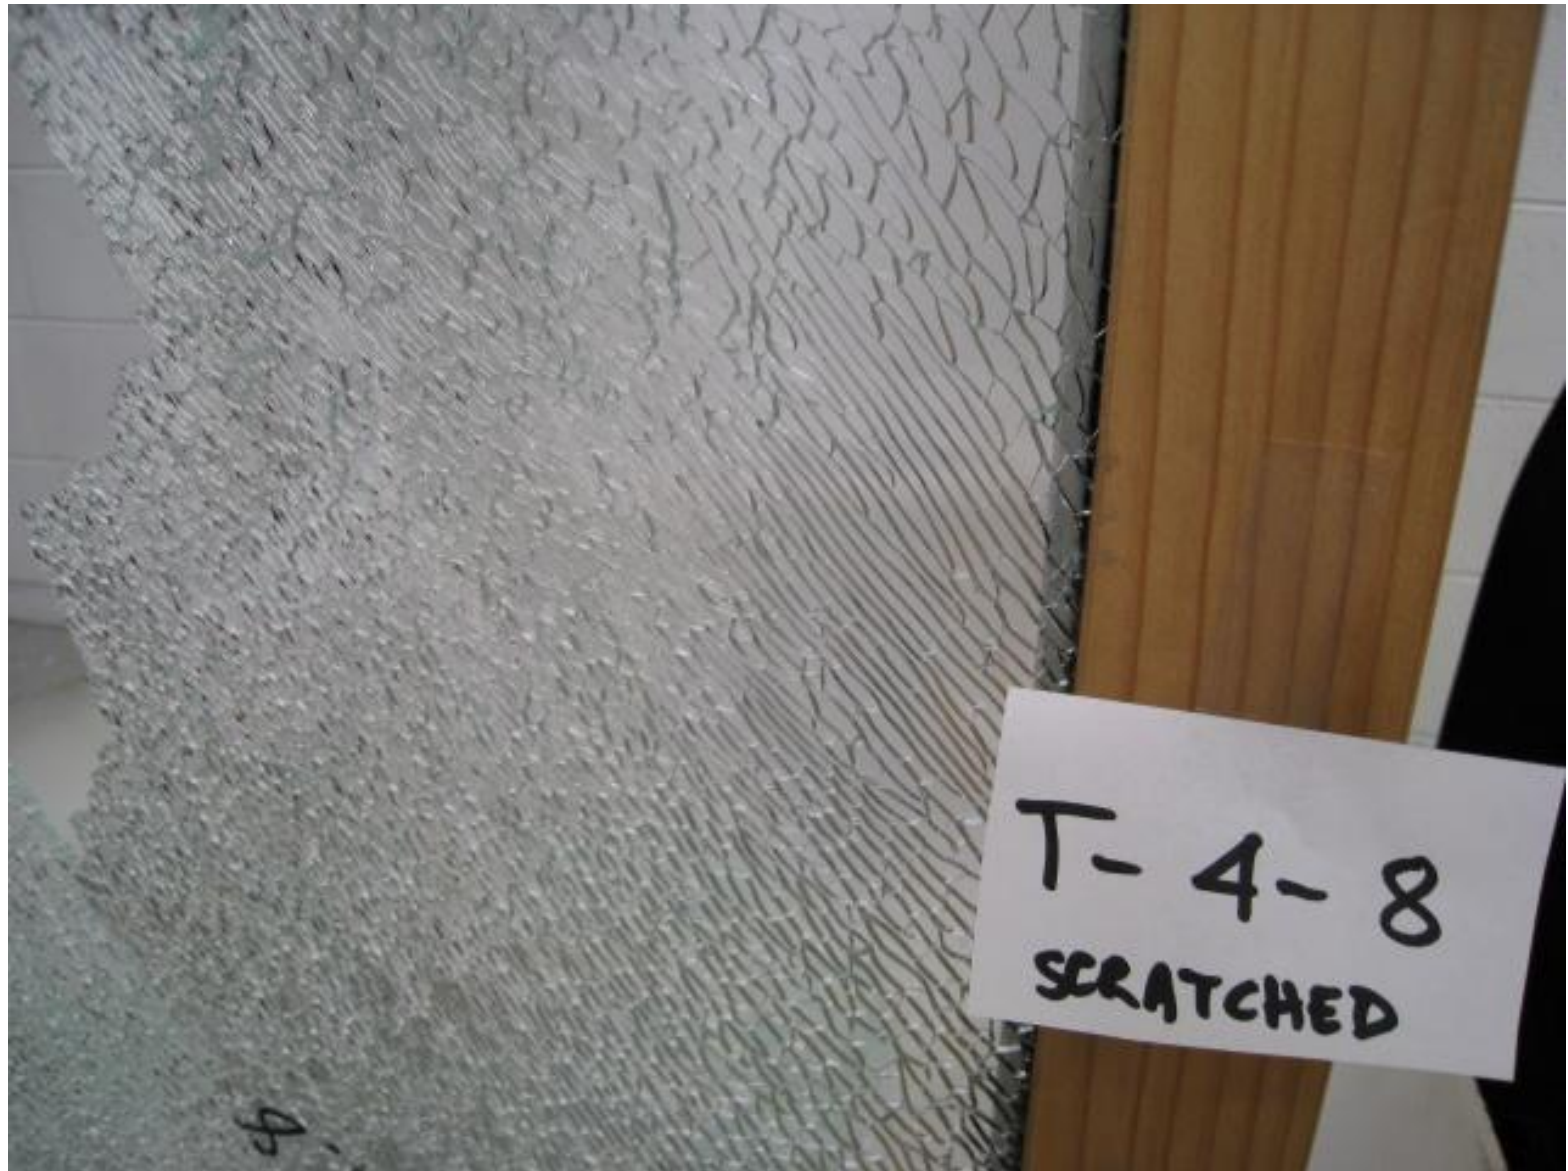
4 mm Sample No.1\_4-8; SC 100: LSB - Glass in frame

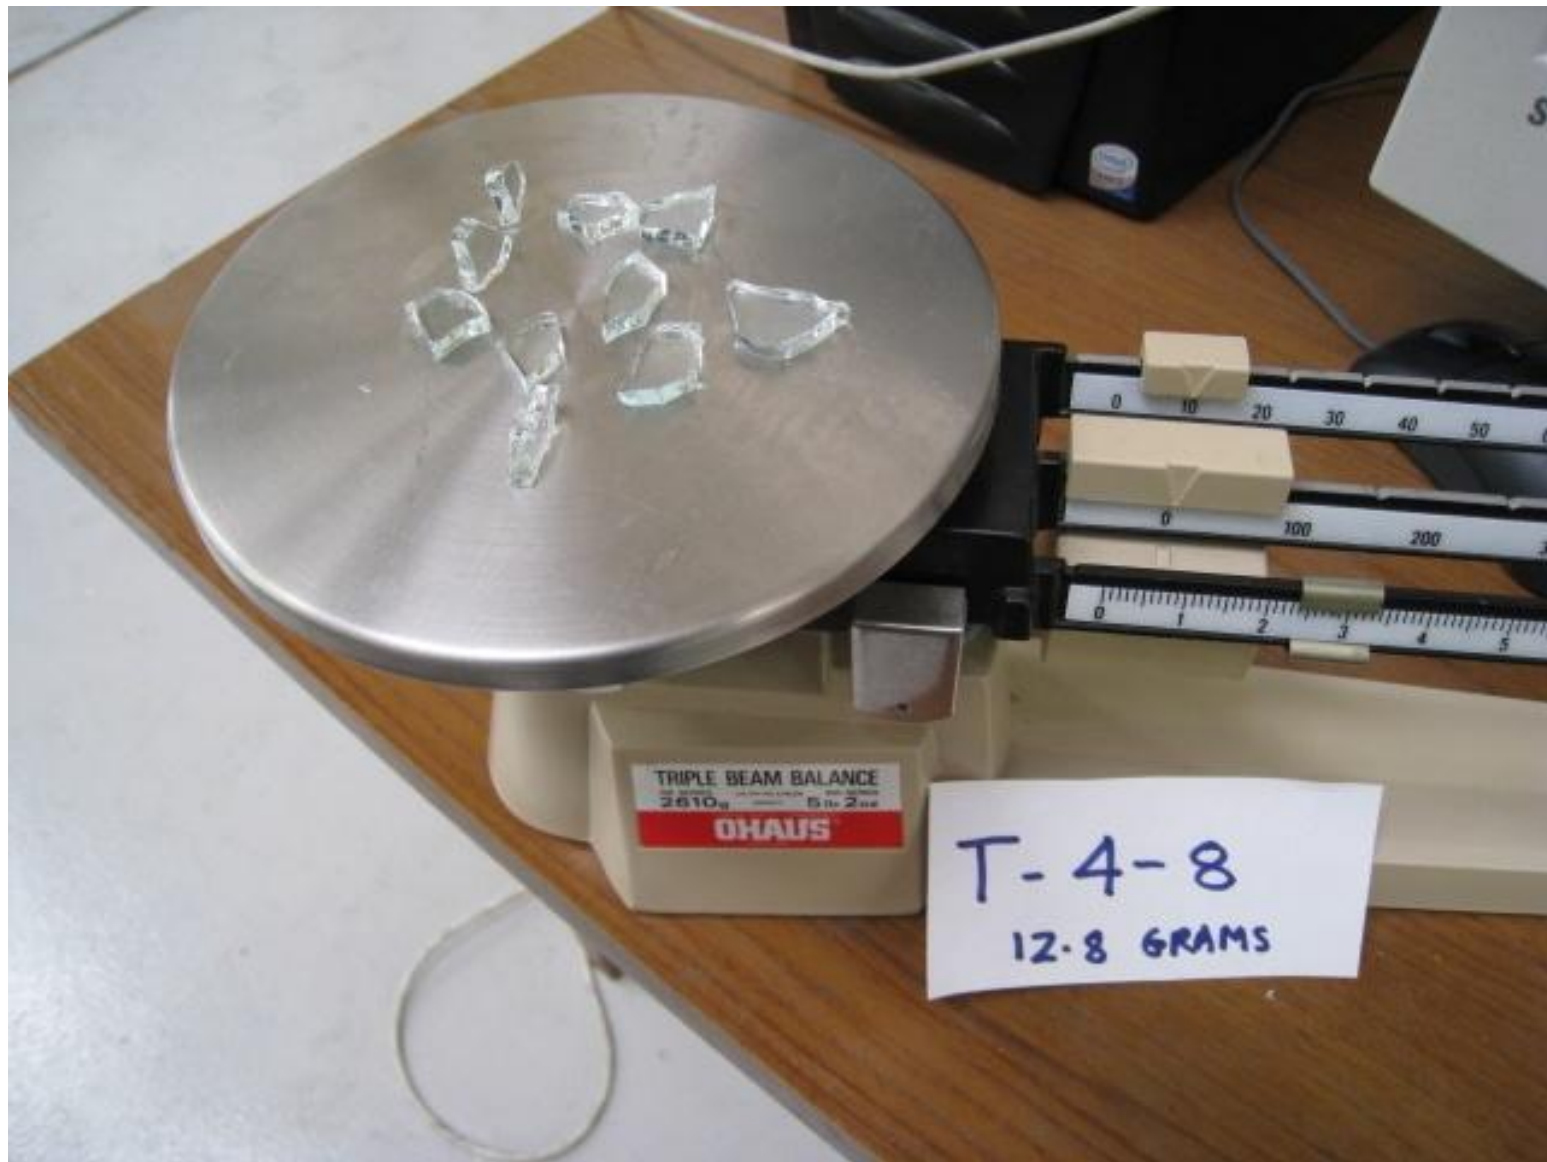
4 mm Sample No. 1\_4-8; SC 100 MPa: LSB impact – 10 largest particles

Weight 12.8 grams – permitted weight 100 grams

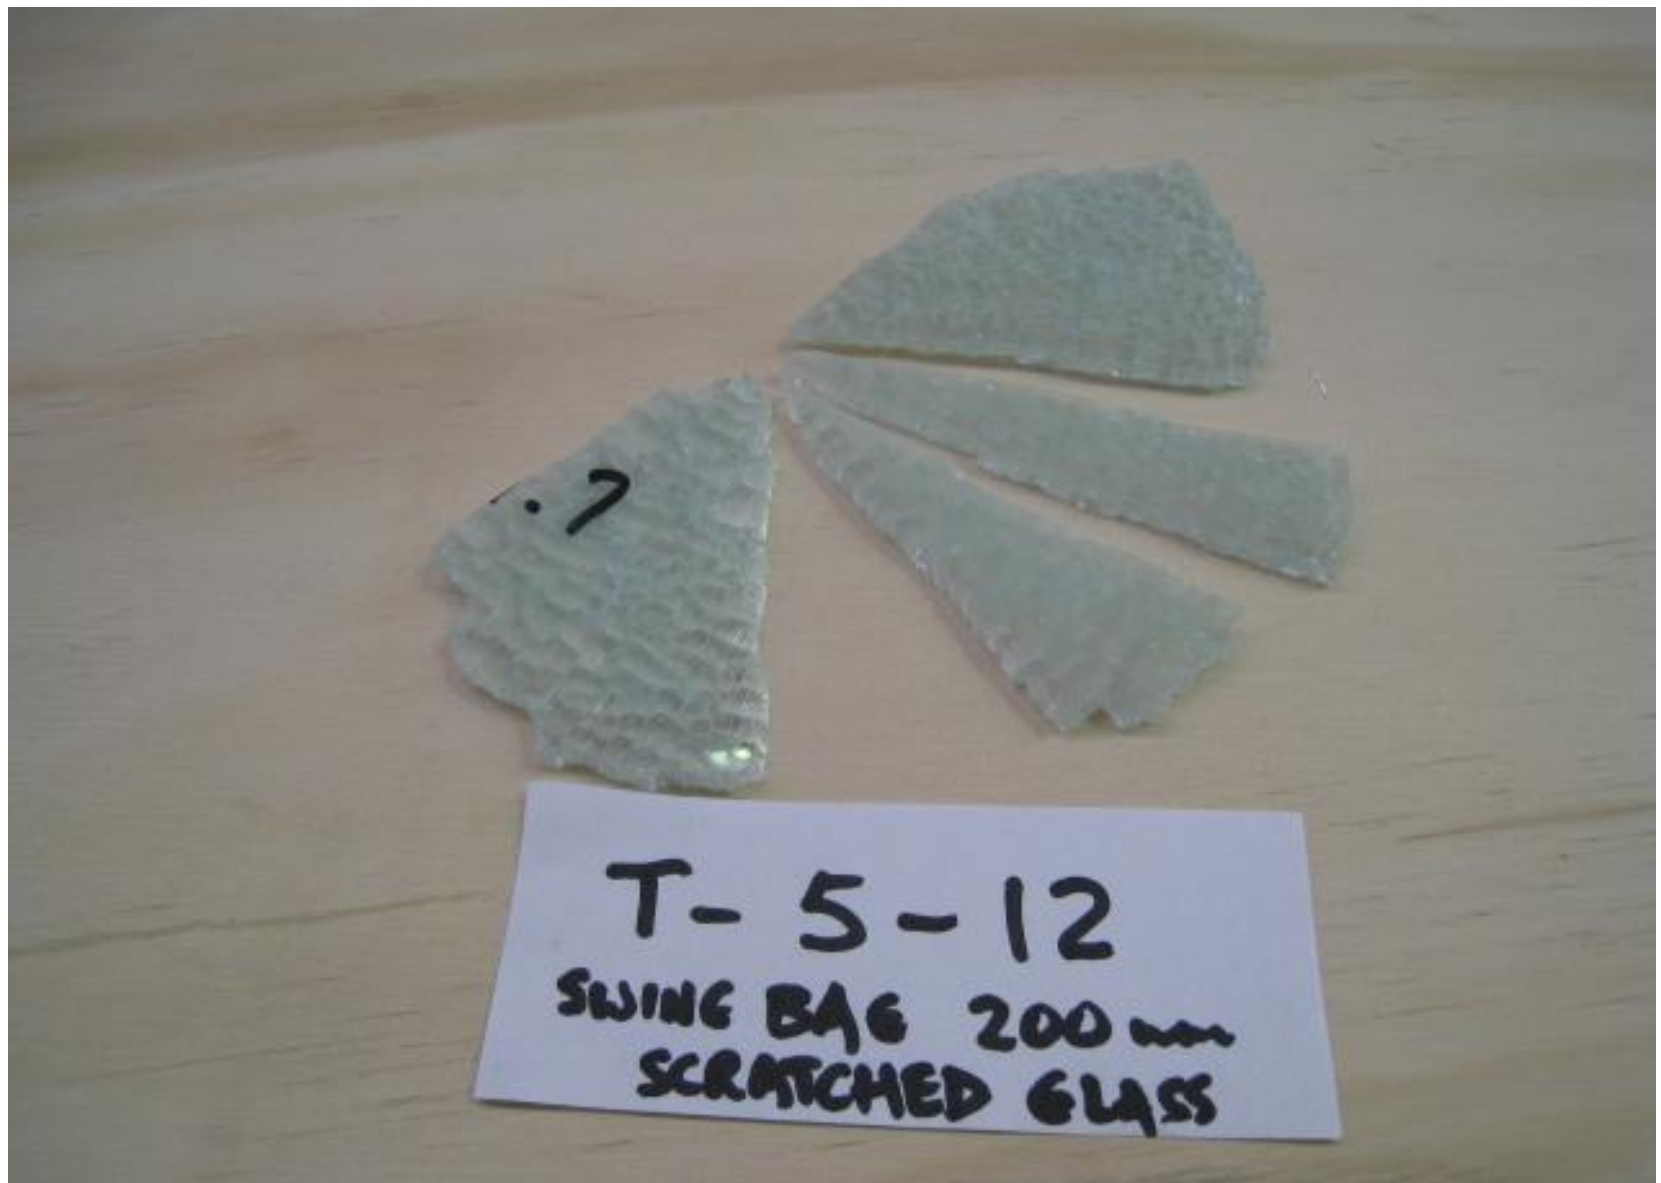
5 mm Sample No.1\_5-12: LSB Impact – Fragments from impact point

- At 69 MPa long fragments will develop
- Particle length is proportional to the surface compression
- All toughened glass will pass the weight of the 10 largest particles criteria even at low levels of surface compression
